General Information

Make	Toyota	Model	Vios
YOM	2023	Odo Meter Reading	30,678
Registration No.	NIF9646	Chassis No.	PA1B18F33N4196770
CC	1.3	Transmission	CVT
Fuel Type	Gas	Type of Body	Sedan
Colour	Blue

Body / Panel Condition

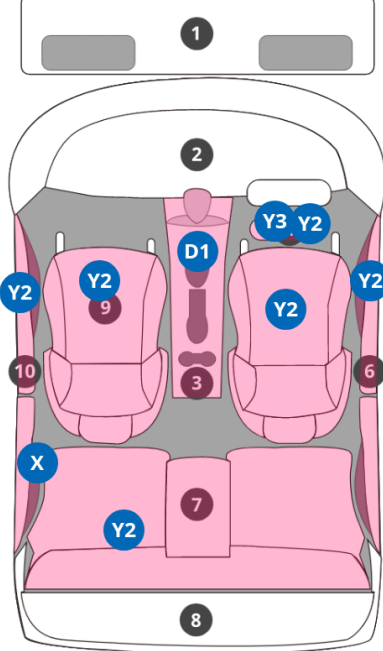
Interior Evaluation : B	Exterior Evaluation : E

<p>a : Cut, Fray d : Loose, Deformed k : Animal Hair s : Smell t : Cigarette Burns x : Defective y : Stain</p>

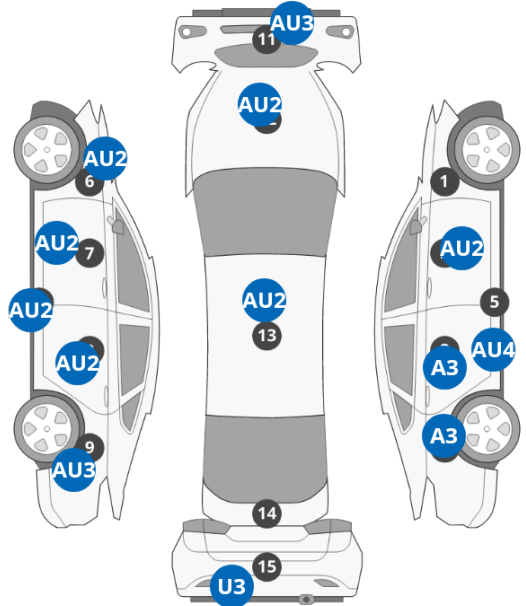
<p>A : Scratch AU : Scratch & Dent B : Modified C : Corrosion G : Stone chip P : Faded S : Rust SC : Rust & Corrosion U : Dent X : Defective Y : Crack, Gap</p>
<p>Remarks (R) Front Floor Mat - Grime - Small / (L) Front Floor Mat - Grime - Medium / (L) Front Seat - Grime - Small / (R) Front Seat - Grime - Small / Rear Seat - Grime - Small / (L) Front Trim - Grime - Small / (R) Front Trim - Grime - Small / Console, Switchs, Vents - Loose, Deformed - Minimal / Trim Other - Missing - Yes</p>	<p>Remarks (R) Step, In-panel, Side Spoiler - Scratch & Dent - Large / (R) Front Door, Molding - Scratch & Dent - Small / (R) Rear Door, Molding - Scratch - Medium / (R) Rear Fender, Molding - Scratch - Medium / (L) Rear Fender, Molding - Scratch & Dent - Medium / Rear Bumper, Lamps, Panels - Dent - Medium / Roof - Scratch & Dent - Small / (L) Front Door, Molding - Scratch & Dent - Small / (L) Rear Door, Molding - Scratch & Dent - Small / (L) Step, In-panel, Side Spoiler - Scratch & Dent - Small / (L) Front Fender, Molding - Scratch & Dent - Small / Bonnet, Headlight - Scratch & Dent - Small / Front Bumper, Grille, Lamps - Scratch & Dent - Medium</p>
