General Information

Make	Toyota	Model	Fortuner
YOM	2024	Odo Meter Reading	48,160
Registration No.	NIU4009	Chassis No.	MHFCB3GSXP0493975
CC	2.4	Transmission	A/T
Fuel Type	Diesel	Type of Body	SUV
Colour	Black

Body / Panel Condition

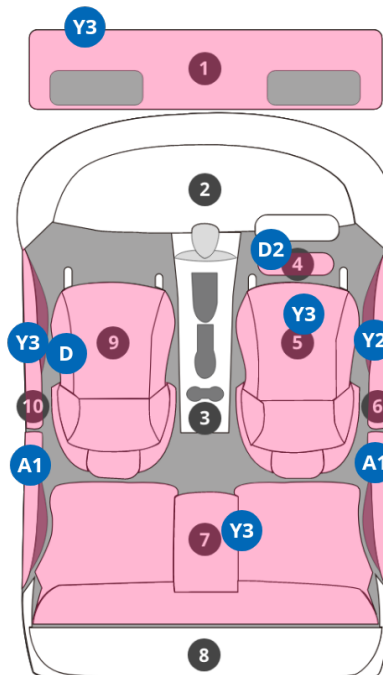
Interior Evaluation : C	Exterior Evaluation : E

<p>a : Cut, Fray d : Loose, Deformed k : Animal Hair s : Smell t : Cigarette Burns x : Defective y : Stain</p>

<p>A : Scratch AU : Scratch & Dent B : Modified C : Corrosion G : Stone chip P : Faded S : Rust SC : Rust & Corrosion U : Dent X : Defective Y : Crack, Gap</p>
<p>Remarks (L) Front Seat - Worn - Yes / (R) Front Seat - Grime - Medium / (L) Front Floor Mat - Worked - Small / Rear Seat - Grime - Medium / (R) Front Trim - Grime - Small / (L) Front Trim - Grime - Medium / Room Lamp - Stuck - Yes / Ceiling - Grime - Medium / (R) Rear Trim - Cut, Crack - Minimal / (L) Rear Trim - Cut, Crack - Minimal</p>	<p>Remarks (R) Rear Door - Repair Traces - Yes / Member (Bolted) - Dent - Yes / (R) Front Fender, Molding - Scratch - Minimal / (R) Mirror - Scratch - Small / (R) Front Door, Molding - Scratch - Small / (R) Rear Door, Molding - Scratch & Dent - Small / (R) Rear Fender, Molding - Scratch - Small / Rear Bumper, Lamps, Panels - Scratch - Medium / Trunk Hood, Rear Gate - Scratch & Dent - Medium / (L) Rear Fender, Molding - Scratch - Medium / (L) Rear Door, Molding - Scratch - Large / (L) Front Door, Molding - Scratch - Small / (L) Front Fender, Molding - Scratch - Medium / (L) Mirror - Scratch - Minimal / Front Bumper, Grille, Lamps - Crack, Gap - Large / Bonnet, Headlight - Scratch & Dent - Minimal / Roof - Scratch & Dent - Small / Front Windshield - Scratch, Stone chip - Large</p>
