General Information

Make	Toyota	Model	Avanza
YOM	2025	Odo Meter Reading	10,999
Registration No.	NJC1605	Chassis No.	MHFAA1BY0S0041018
CC	1.3	Transmission	CVT
Fuel Type	Gas	Type of Body	Wagon
Colour	Green

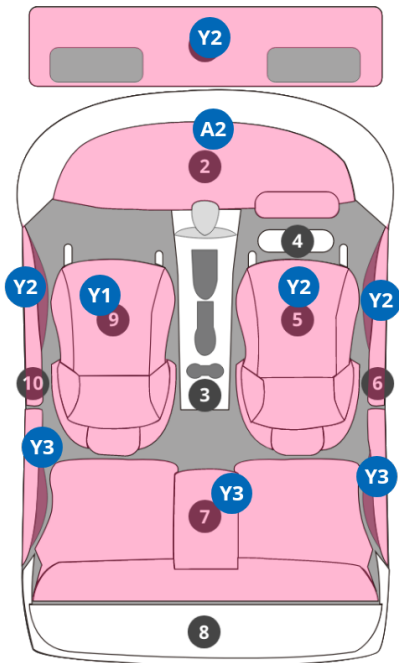
Interior Evaluation : C	Exterior Evaluation : D

<p>a : Cut, Fray d : Loose, Deformed k : Animal Hair s : Smell t : Cigarette Burns x : Defective y : Stain</p>

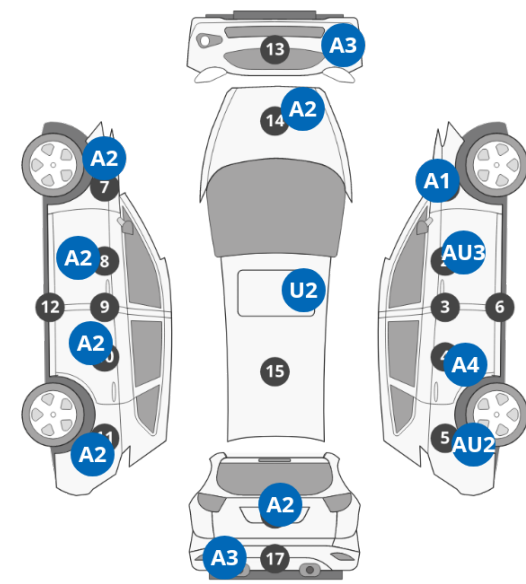
<p>A : Scratch AU : Scratch & Dent B : Modified C : Corrosion G : Stone chip P : Faded S : Rust SC : Rust & Corrosion U : Dent X : Defective Y : Crack, Gap</p>
<p>Remarks (R) Front Seat - Grime - Small / Rear Seat - Grime - Medium / (R) Rear Trim - Grime - Medium / (R) Front Trim - Grime - Small / Dashboard - Worn, Scratch, Cut, Crack - Small / (L) Rear Trim - Grime - Medium / (L) Front Trim - Grime - Small / Ceiling - Grime - Small / (L) Front Seat - Grime - Minimal</p>	<p>Remarks (R) Rear Door, Molding - Scratch - Large / (R) Rear Fender, Molding - Scratch & Dent - Small / (R) Front Door, Molding - Scratch & Dent - Medium / (R) Front Fender, Molding - Scratch - Minimal / Front Bumper, Grille, Lamps - Scratch - Medium / Bonnet, Headlight - Scratch - Small / (L) Front Fender, Molding - Scratch - Small / (L) Front Door, Molding - Scratch - Small / (L) Rear Door, Molding - Scratch - Small / (L) Rear Fender, Molding - Scratch - Small / Rear Bumper, Lamps, Panels - Scratch - Medium / Trunk Hood, Rear Gate - Scratch - Small / Roof - Dent - Small</p>
