General Information

Make	Toyota	Model	Vios
YOM	2025	Odo Meter Reading	13,092
Registration No.	NJF2084	Chassis No.	PA1B18F39R4275687
CC	1.3	Transmission	CVT
Fuel Type	Gas	Type of Body	Sedan
Colour	Black

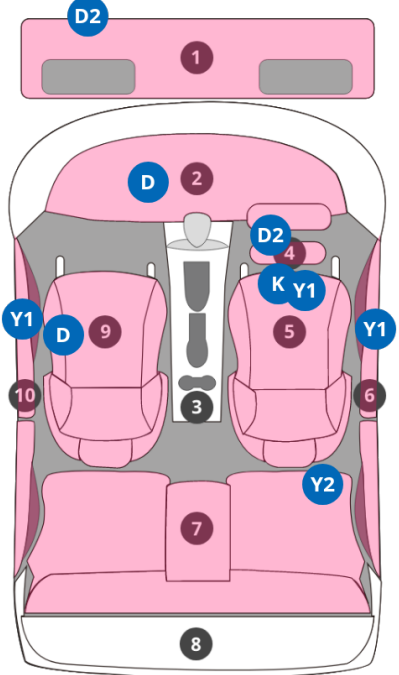
Interior Evaluation : B	Exterior Evaluation : C

<p>a : Cut, Fray d : Loose, Deformed k : Animal Hair s : Smell t : Cigarette Burns x : Defective y : Stain</p>

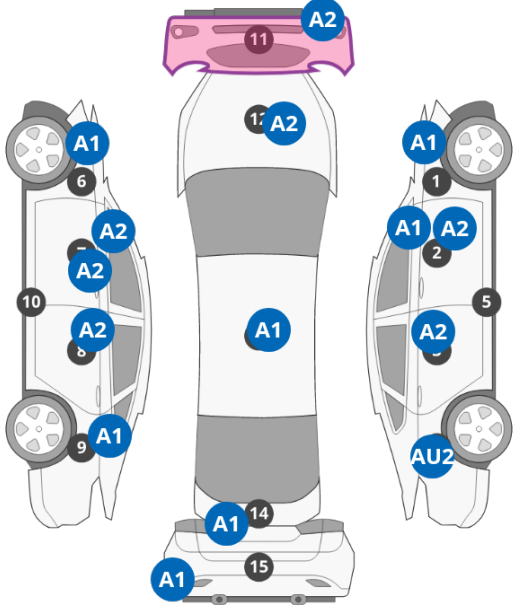
<p>A : Scratch AU : Scratch & Dent B : Modified C : Corrosion G : Stone chip P : Faded S : Rust SC : Rust & Corrosion U : Dent X : Defective Y : Crack, Gap</p>
<p>Remarks (L) Front Seat - Worn - Yes / Overall Interior - Animal Hair - Yes / (R) Front Seat - Grime - Minimal / Ceiling - Crinkle - Small / (L) Front Trim - Grime - Minimal / (R) Front Trim - Grime - Minimal / Rear Seat - Grime - Small / (L) Front Floor Mat - Worked - Small / Dashboard - Traces of Adhesive Tape - Yes</p>	<p>Remarks (R) Front Fender, Molding - Scratch - Minimal / (R) Mirror - Scratch - Minimal / (R) Front Door, Molding - Scratch - Small / (R) Rear Door, Molding - Scratch - Small / (R) Rear Fender, Molding - Scratch & Dent - Small / Rear Bumper, Lamps, Panels - Scratch - Minimal / Trunk Hood, Rear Gate - Scratch - Minimal / (L) Rear Fender, Molding - Scratch - Minimal / (L) Front Door, Molding - Scratch - Small / (L) Rear Door, Molding - Scratch - Small / (L) Mirror - Scratch - Small / (L) Front Fender, Molding - Scratch - Minimal / Front Bumper, Grille, Lamps - Scratch - Small / Front Bumper, Grille, Lamps - Repair mark - Yes / Bonnet, Headlight - Scratch - Small / Roof - Scratch - Minimal</p>
