General Information

Make	Toyota	Model	Raize
YOM	2025	Odo Meter Reading	9,457
Registration No.	NJF6954	Chassis No.	MHKABA1BA9SJ117637
CC	1.2	Transmission	CVT
Fuel Type	Gas	Type of Body	Wagon
Colour	Silver

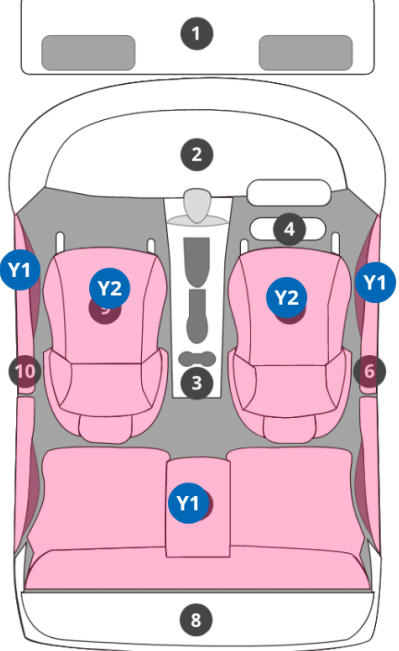
Interior Evaluation : A	Exterior Evaluation : C

<p>a : Cut, Fray d : Loose, Deformed k : Animal Hair s : Smell t : Cigarette Burns x : Defective y : Stain</p>

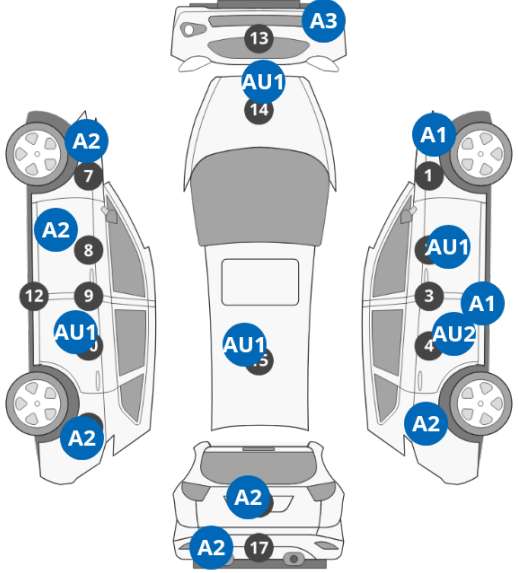
<p>A : Scratch AU : Scratch & Dent B : Modified C : Corrosion G : Stone chip P : Faded S : Rust SC : Rust & Corrosion U : Dent X : Defective Y : Crack, Gap</p>
<p>Remarks (L) Front Seat - Grime - Small / (R) Front Seat - Grime - Small / Rear Seat - Grime - Minimal / (R) Front Trim - Grime - Minimal / (L) Front Trim - Grime - Minimal</p>	<p>Remarks Front Bumper, Grille, Lamps - Scratch - Medium / Bonnet, Headlight - Scratch & Dent - Minimal / (R) Front Fender, Molding - Scratch - Minimal / (R) Front Door, Molding - Scratch & Dent - Minimal / (R) Rear Door, Molding - Scratch & Dent - Small / (R) Step, In-panel, Side Spoiler - Scratch - Minimal / (R) Rear Fender, Molding - Scratch - Small / Rear Bumper, Lamps, Panels - Scratch - Small / Trunk Hood, Rear Gate - Scratch - Small / Roof - Scratch & Dent - Minimal / (L) Rear Door, Molding - Scratch & Dent - Minimal / (L) Rear Fender, Molding - Scratch - Small / (L) Front Door, Molding - Scratch - Small / (L) Front Fender, Molding - Scratch - Small</p>
