## General Information

<b>Make</b>	Toyota	<b>Model</b>	Vios
<b>YOM</b>	2024	<b>Odo Meter Reading</b>	20,135
<b>Registration No.</b>	NKD6529	<b>Chassis No.</b>	PA1B18F38R4252174
<b>CC</b>	1.3	<b>Transmission</b>	CVT
<b>Fuel Type</b>	Gas	<b>Type of Body</b>	Sedan
<b>Colour</b>	Red

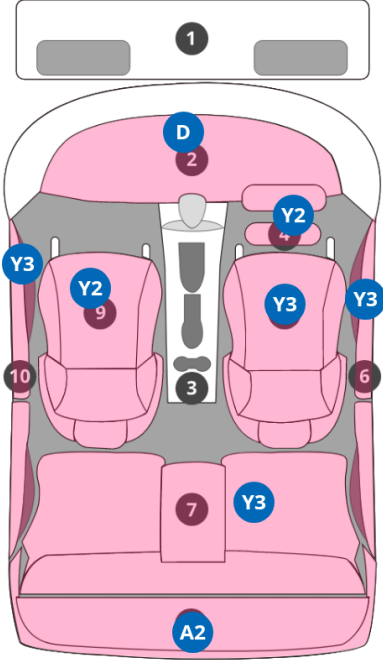
<b>Interior Evaluation :</b> <span style="float: right; color: red; font-weight: bold;">C</span>	<b>Exterior Evaluation :</b> <span style="float: right; color: red; font-weight: bold;">E</span>

<p><b>a</b> : Cut, Fray <b>d</b> : Loose, Deformed <b>k</b> : Animal Hair <b>s</b> : Smell <b>t</b> : Cigarette Burns <b>x</b> : Defective <b>y</b> : Stain</p>

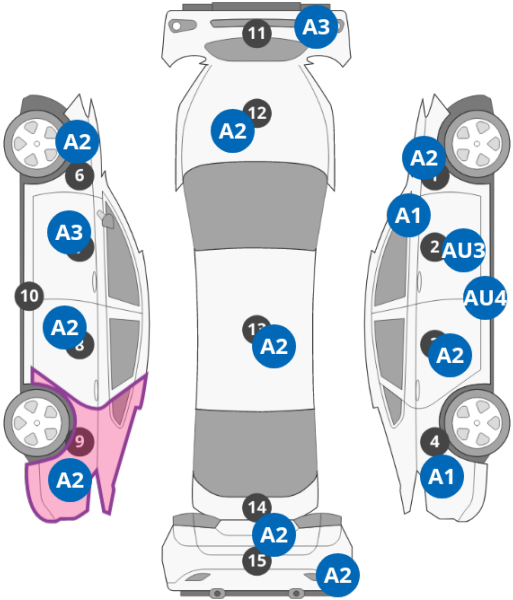
<p><b>A</b> : Scratch <b>AU</b> : Scratch &amp; Dent <b>B</b> : Modified <b>C</b> : Corrosion <b>G</b> : Stone chip <b>P</b> : Faded <b>S</b> : Rust <b>SC</b> : Rust &amp; Corrosion <b>U</b> : Dent <b>X</b> : Defective <b>Y</b> : Crack, Gap</p>
<p><b>Remarks</b> (R) Front Seat - Grime - Medium / (R) Front Trim - Grime - Medium / Rear Seat - Grime - Medium / Trunk Room - Worn, Scratch, Cut, Crack - Small / (L) Front Trim - Grime - Medium / (L) Front Floor Mat - Grime - Small / Dashboard - Traces of Adhesive Tape - Yes / (L) Front Seat - Grime - Small</p>	<p><b>Remarks</b> (R) Front Fender - Repair Traces - Yes / (L) Front Door, Molding - Scratch - Medium / (L) Rear Fender, Molding - Repair mark - Yes / (L) Rear Door, Molding - Scratch - Small / (L) Rear Fender, Molding - Scratch - Small / (L) Front Fender, Molding - Scratch - Small / Bonnet, Headlight - Scratch - Small / Front Bumper, Grille, Lamps - Scratch - Medium / (R) Front Fender, Molding - Scratch - Small / (R) Mirror - Scratch - Minimal / (R) Step, In-panel, Side Spoiler - Scratch &amp; Dent - Large / (R) Front Door, Molding - Scratch &amp; Dent - Medium / (R) Rear Door, Molding - Scratch - Small / (R) Rear Fender, Molding - Scratch - Minimal / Trunk Hood, Rear Gate - Scratch - Small / Rear Bumper, Lamps, Panels - Scratch - Small / Roof - Scratch - Small</p>
