General Information

Make	Toyota	Model	Vios
YOM	2025	Odo Meter Reading	12,861
Registration No.	HAG8478	Chassis No.	PA1B18F38R4262557
CC	1.3	Transmission	CVT
Fuel Type	Gas	Type of Body	Sedan
Colour	Black

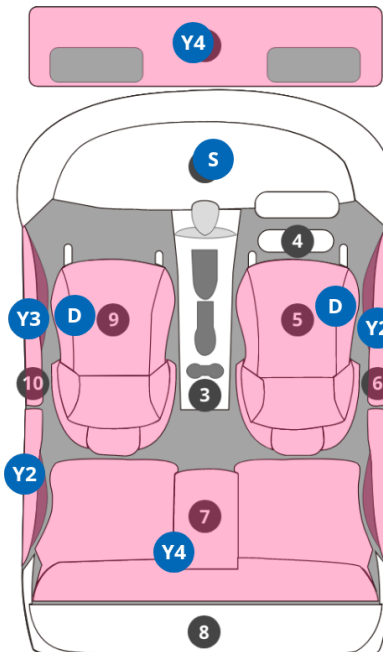
Interior Evaluation : C	Exterior Evaluation : E

<p>a : Cut, Fray d : Loose, Deformed k : Animal Hair s : Smell t : Cigarette Burns x : Defective y : Stain</p>

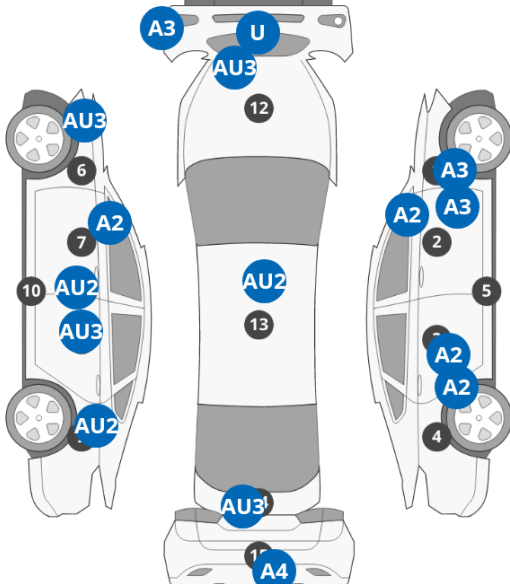
<p>A : Scratch AU : Scratch & Dent B : Modified C : Corrosion G : Stone chip P : Faded S : Rust SC : Rust & Corrosion U : Dent X : Defective Y : Crack, Gap</p>
<p>Remarks Overall Interior - Worn as per age - Yes / Overall Interior - Smell - Yes / (L) Front Seat - Worn - Yes / (R) Front Seat - Worn - Yes / Rear Seat - Grime - Large / Ceiling - Grime - Large / (R) Front Trim - Grime - Small / (L) Front Trim - Grime - Medium / (L) Rear Trim - Grime - Small</p>	<p>Remarks (R) Front Fender, Molding - Scratch - Medium / (R) Mirror - Scratch - Small / (R) Front Door, Molding - Scratch - Medium / (R) Rear Door, Molding - Scratch - Small / (R) Rear Fender, Molding - Scratch - Small / Rear Bumper, Lamps, Panels - Scratch - Large / Trunk Hood, Rear Gate - Scratch & Dent - Medium / (L) Rear Door, Molding - Scratch & Dent - Medium / (L) Rear Fender, Molding - Scratch & Dent - Small / (L) Mirror - Scratch - Small / (L) Front Door, Molding - Scratch & Dent - Small / (L) Front Fender, Molding - Scratch & Dent - Medium / Front Bumper, Grille, Lamps - Scratch - Medium / Member (Bolted) - Dent - Yes / Bonnet, Headlight - Scratch & Dent - Medium / Roof - Scratch & Dent - Small</p>
