General Information

Make	Toyota	Model	Hilux Tamaraw
YOM	2025	Odo Meter Reading	2,544
Registration No.	VAC4411	Chassis No.	PAHACACA6S6423497
CC	2.4	Transmission	M/T
Fuel Type	Diesel	Type of Body	Utility Passenger
Colour	White

Body / Panel Condition

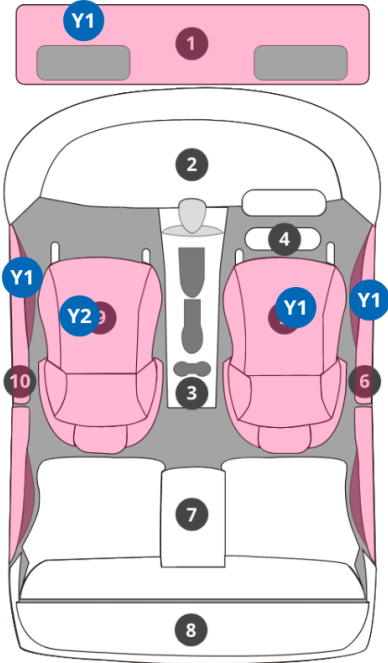
Interior Evaluation : A	Exterior Evaluation : B

<p>a : Cut, Fray d : Loose, Deformed k : Animal Hair s : Smell t : Cigarette Burns x : Defective y : Stain</p>

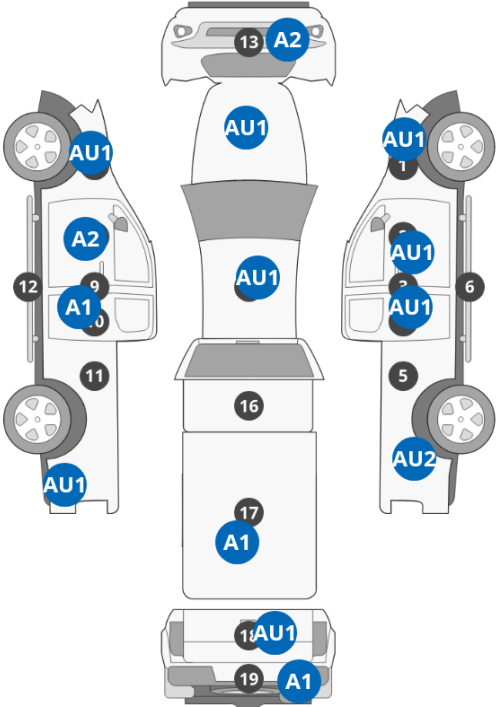
<p>A : Scratch AU : Scratch & Dent B : Modified C : Corrosion G : Stone chip P : Faded S : Rust SC : Rust & Corrosion U : Dent X : Defective Y : Crack, Gap</p>
<p>Remarks (L) Front Seat - Grime - Small / (R) Front Seat - Grime - Minimal / (L) Front Trim - Grime - Minimal / (R) Front Trim - Grime - Minimal / Ceiling - Grime - Minimal</p>	<p>Remarks (R) Side Gate - Scratch & Dent - Small / Roof - Scratch & Dent - Minimal / Rear Gate - Scratch & Dent - Minimal / Rear Bumper, Lamps, Panels - Scratch - Minimal / (L) Side Gate - Scratch & Dent - Minimal / (L) Front Door, Molding - Scratch - Small / (L) Rear Door, Molding - Scratch - Minimal / (L) Front Fender, Molding - Scratch & Dent - Minimal / Bonnet, Headlight - Scratch & Dent - Minimal / (R) Front Fender, Molding - Scratch & Dent - Minimal / (R) Front Door, Molding - Scratch & Dent - Minimal / (R) Rear Door, Molding - Scratch & Dent - Minimal / Front Bumper, Grille, Lamps - Scratch - Small / Cargo Bed Floor - Scratch - Minimal</p>
