## General Information

<b>Make</b>	Toyota	<b>Model</b>	Vios
<b>YOM</b>	2021	<b>Odo Meter Reading</b>	17,042
<b>Registration No.</b>	DAV7559	<b>Chassis No.</b>	PA1B18F36M4150316
<b>CC</b>	1.3	<b>Transmission</b>	CVT
<b>Fuel Type</b>	Gas	<b>Type of Body</b>	Sedan
<b>Colour</b>	Silver

## Body / Panel Condition

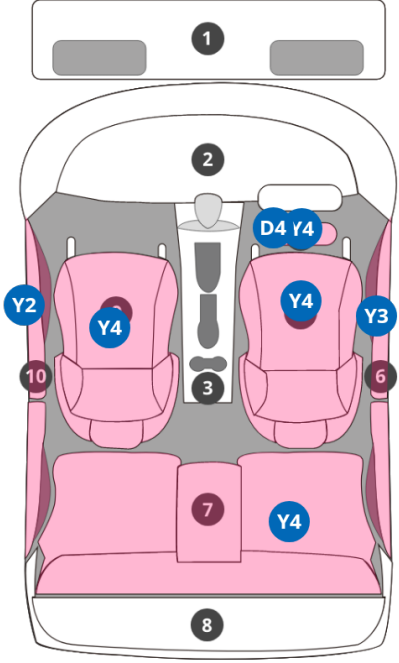
<b>Interior Evaluation :</b> <span style="float: right; color: red; font-weight: bold;">D</span>	<b>Exterior Evaluation :</b> <span style="float: right; color: red; font-weight: bold;">C</span>

<p><b>a</b> : Cut, Fray <b>d</b> : Loose, Deformed <b>k</b> : Animal Hair <b>s</b> : Smell <b>t</b> : Cigarette Burns <b>x</b> : Defective <b>y</b> : Stain</p>

<p><b>A</b> : Scratch <b>AU</b> : Scratch &amp; Dent <b>B</b> : Modified <b>C</b> : Corrosion <b>G</b> : Stone chip <b>P</b> : Faded <b>S</b> : Rust <b>SC</b> : Rust &amp; Corrosion <b>U</b> : Dent <b>X</b> : Defective <b>Y</b> : Crack, Gap</p>
<p><b>Remarks</b> (R) Front Seat - Grime - Large / Rear Seat - Grime - Large / Mat Other - Grime - Large / (R) Front Trim - Grime - Medium / (L) Front Trim - Grime - Small / (L) Front Seat - Grime - Large / (L) Front Floor Mat - Worked - Large</p>	<p><b>Remarks</b> Front Bumper, Grille, Lamps - Scratch &amp; Dent - Large / (R) Front Door, Molding - Scratch - Medium / (R) Rear Door, Molding - Dent - Small / Rear Bumper, Lamps, Panels - Scratch - Medium / Trunk Hood, Rear Gate - Scratch - Small / (L) Rear Fender, Molding - Scratch - Small / (L) Front Door, Molding - Scratch - Small / (L) Rear Door, Molding - Scratch - Small / (L) Front Fender, Molding - Scratch - Small / Bonnet, Headlight - Scratch &amp; Dent - Small / (R) Rear Fender, Molding - Scratch - Small</p>
