General Information

Make	Toyota	Model	Hilux
YOM	2024	Odo Meter Reading	14,008
Registration No.	DBF5603	Chassis No.	MR0AB8DD8R5152085
CC	2.4	Transmission	A/T
Fuel Type	Diesel	Type of Body	Pickup
Colour	Red

Body / Panel Condition

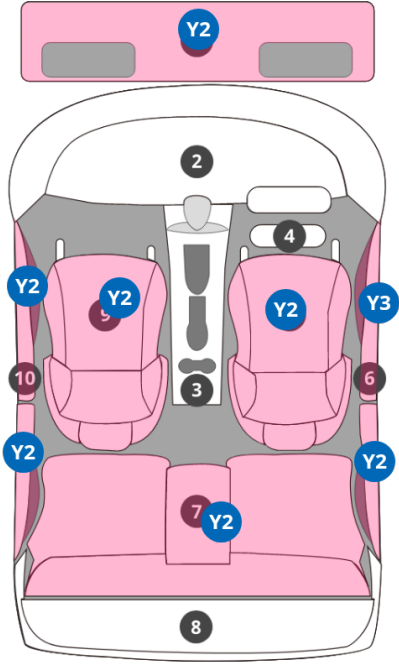
Interior Evaluation : B	Exterior Evaluation : E

<p>a : Cut, Fray d : Loose, Deformed k : Animal Hair s : Smell t : Cigarette Burns x : Defective y : Stain</p>

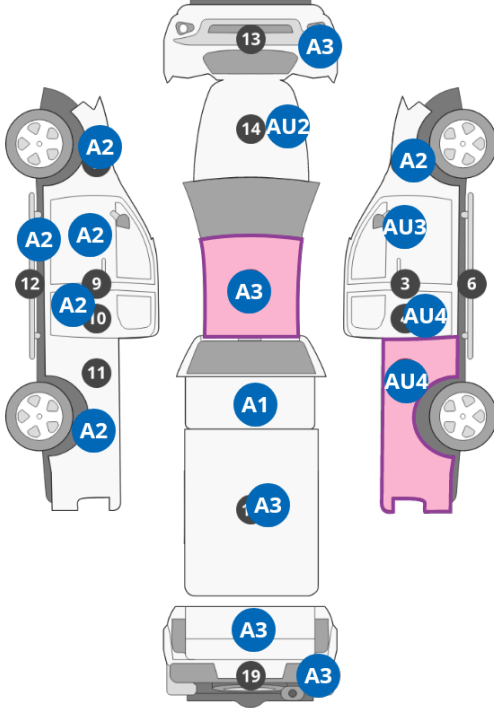
<p>A : Scratch AU : Scratch & Dent B : Modified C : Corrosion G : Stone chip P : Faded S : Rust SC : Rust & Corrosion U : Dent X : Defective Y : Crack, Gap</p>
<p>Remarks (R) Front Trim - Grime - Medium / (R) Front Seat - Grime - Small / Rear Seat - Grime - Small / (R) Rear Trim - Grime - Small / (L) Rear Trim - Grime - Small / (L) Front Trim - Grime - Small / (L) Front Seat - Grime - Small / Ceiling - Grime - Small</p>	<p>Remarks Roof - Repair Traces - Yes / (L) Guard Frame - Scratch - Small / (L) Rear Door, Molding - Scratch - Small / (L) Front Door, Molding - Scratch - Small / (L) Step, In-panel, Side Spoiler - Scratch - Small / (L) Front Fender, Molding - Scratch - Small / Front Bumper, Grille, Lamps - Scratch - Medium / Roof - Repair mark - Yes / Bonnet, Headlight - Scratch & Dent - Small / (R) Front Fender, Molding - Scratch - Small / (R) Front Door, Molding - Scratch & Dent - Medium / (R) Rear Door, Molding - Scratch & Dent - Large / (R) Guard Frame - Scratch & Dent - Large / Rear Gate - Scratch - Medium / Rear Bumper, Lamps, Panels - Scratch - Medium / Cargo Bed Floor - Scratch - Medium / Roof - Scratch - Medium / Cab Back Panel - Scratch - Minimal / (R) Guard Frame - Partially Missing - Yes</p>
