General Information

Make	Toyota	Model	Vios
YOM	2024	Odo Meter Reading	32,461
Registration No.	DBJ8790	Chassis No.	PA1B18F34P4228077
CC	1.3	Transmission	CVT
Fuel Type	Gas	Type of Body	Sedan
Colour	Green

Body / Panel Condition

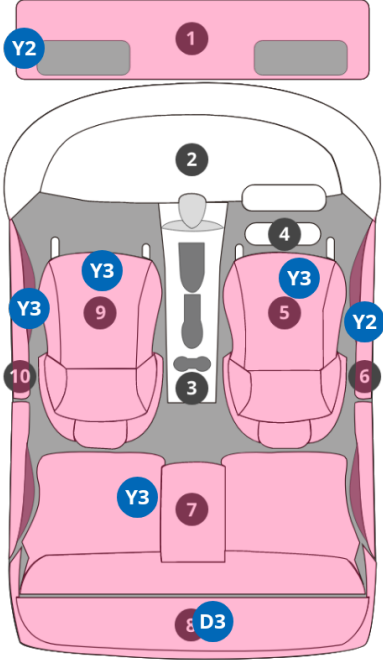
Interior Evaluation : C	Exterior Evaluation : D

<p>a : Cut, Fray d : Loose, Deformed k : Animal Hair s : Smell t : Cigarette Burns x : Defective y : Stain</p>

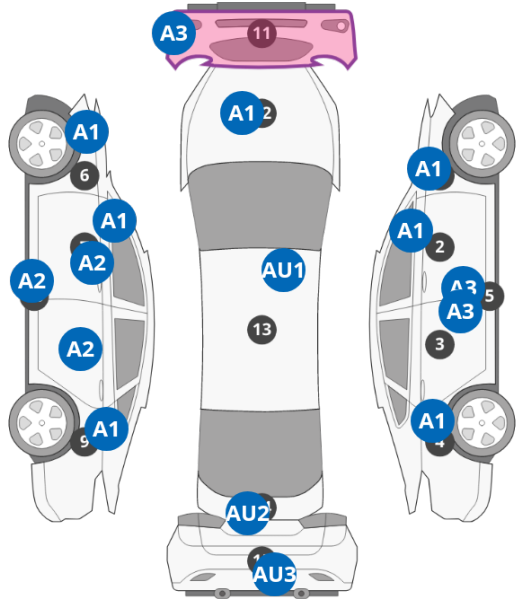
<p>A : Scratch AU : Scratch & Dent B : Modified C : Corrosion G : Stone chip P : Faded S : Rust SC : Rust & Corrosion U : Dent X : Defective Y : Crack, Gap</p>
<p>Remarks (L) Front Seat - Grime - Medium / (R) Front Seat - Grime - Medium / (R) Front Trim - Grime - Small / (L) Front Trim - Grime - Medium / Ceiling - Grime - Small / Rear Seat - Grime - Medium / Trunk Room - Loose, Deformed - Medium</p>	<p>Remarks (R) Front Fender, Molding - Scratch - Minimal / (R) Mirror - Scratch - Minimal / (R) Front Door, Molding - Scratch - Medium / (R) Rear Door, Molding - Scratch - Medium / (R) Rear Fender, Molding - Scratch - Minimal / Rear Bumper, Lamps, Panels - Scratch & Dent - Medium / Trunk Hood, Rear Gate - Scratch & Dent - Small / (L) Rear Fender, Molding - Scratch - Minimal / (L) Step, In-panel, Side Spoiler - Scratch - Small / (L) Rear Door, Molding - Scratch - Small / (L) Front Door, Molding - Scratch - Small / (L) Mirror - Scratch - Minimal / Front Bumper, Grille, Lamps - Repair mark - Yes / (L) Front Fender, Molding - Scratch - Minimal / Front Bumper, Grille, Lamps - Scratch - Medium / Bonnet, Headlight - Scratch - Minimal / Roof - Scratch & Dent - Minimal</p>
