General Information

Make	Toyota	Model	Vios
YOM	2024	Odo Meter Reading	108,071
Registration No.	NHR1952	Chassis No.	PA1B18F37P4227294
CC	1.3	Transmission	CVT
Fuel Type	Gas	Type of Body	Sedan
Colour	Red

Body / Panel Condition

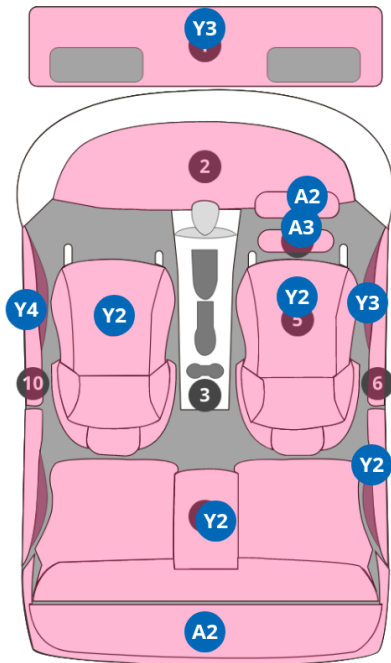
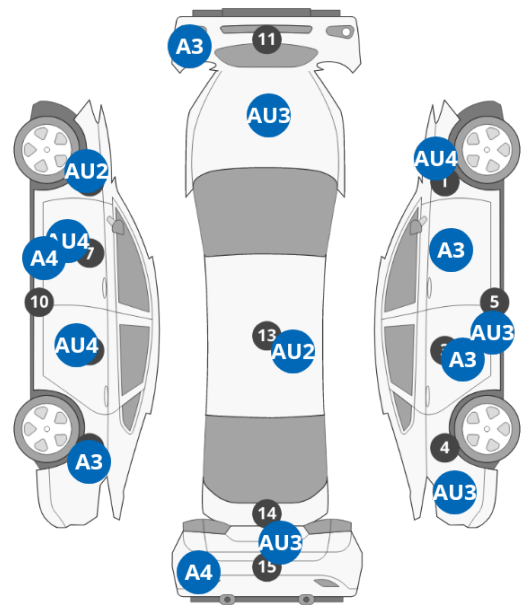
Interior Evaluation :	C	Exterior Evaluation :	E

<p>a : Cut, Fray d : Loose, Deformed k : Animal Hair s : Smell t : Cigarette Burns x : Defective y : Stain</p>		<p>A : Scratch AU : Scratch & Dent B : Modified C : Corrosion G : Stone chip P : Faded S : Rust SC : Rust & Corrosion U : Dent X : Defective Y : Crack, Gap</p>	
<p>Remarks (R) Front Trim - Grime - Medium / (R) Front Seat - Grime - Small / Rear Seat - Grime - Small / (R) Rear Trim - Grime - Small / Trunk Room - Worn, Scratch, Cut, Crack - Small / (L) Front Trim - Grime - Large / (L) Front Seat - Grime - Small / (L) Front Floor Mat - Cut, Crack - Medium / Ceiling - Grime - Medium / Steering Wheel - Worn, Peel, Crack - Small</p>		<p>Remarks Bonnet, Headlight - Scratch & Dent - Medium / Front Bumper, Grille, Lamps - Scratch - Medium / (L) Front Fender, Molding - Scratch & Dent - Small / (L) Front Door, Molding - Scratch & Dent - Large / (L) Step, In-panel, Side Spoiler - Scratch - Large / (L) Rear Door, Molding - Scratch & Dent - Large / (L) Rear Fender, Molding - Scratch - Medium / Rear Bumper, Lamps, Panels - Scratch - Large / Trunk Hood, Rear Gate - Scratch & Dent - Medium / (R) Rear Fender, Molding - Scratch & Dent - Medium / (R) Rear Door, Molding - Scratch - Medium / (R) Step, In-panel, Side Spoiler - Scratch & Dent - Medium / (R) Front Door, Molding - Scratch - Medium / (R) Front Fender, Molding - Scratch & Dent - Large / Roof - Scratch & Dent - Small</p>
