General Information

Make	Toyota	Model	Rush
YOM	2022	Odo Meter Reading	44,490
Registration No.	NIE5462	Chassis No.	MHKE8FF3PNK047056
CC	1.5	Transmission	A/T
Fuel Type	Gas	Type of Body	SUV
Colour	White

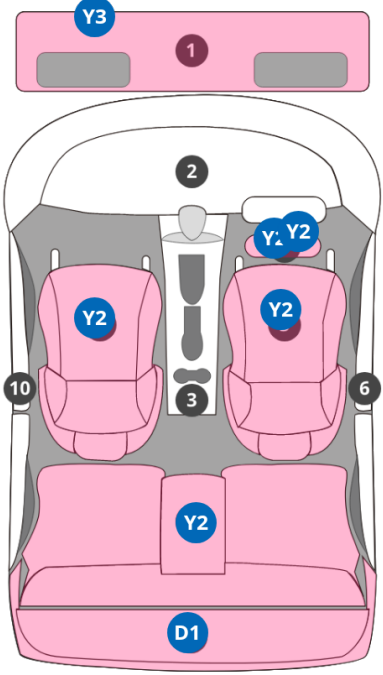
Interior Evaluation : B	Exterior Evaluation : C

<p>a : Cut, Fray d : Loose, Deformed k : Animal Hair s : Smell t : Cigarette Burns x : Defective y : Stain</p>

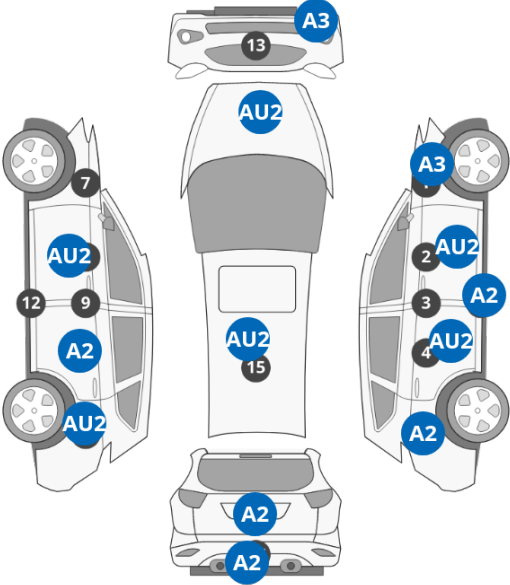
<p>A : Scratch AU : Scratch & Dent B : Modified C : Corrosion G : Stone chip P : Faded S : Rust SC : Rust & Corrosion U : Dent X : Defective Y : Crack, Gap</p>
<p>Remarks Ceiling - Grime - Medium / Rear Seat - Grime - Small / (R) Front Seat - Grime - Small / (L) Front Seat - Grime - Small / (L) Front Floor Mat - Grime - Small / (R) Front Floor Mat - Grime - Small / Trunk Room - Worked - Minimal</p>	<p>Remarks (R) Rear Door, Molding - Scratch & Dent - Small / (R) Rear Fender, Molding - Scratch - Small / Trunk Hood, Rear Gate - Scratch - Small / (L) Rear Fender, Molding - Scratch & Dent - Small / Rear Bumper, Lamps, Panels - Scratch - Small / (L) Rear Door, Molding - Scratch - Small / (L) Front Door, Molding - Scratch & Dent - Small / Roof - Scratch & Dent - Small / Bonnet, Headlight - Scratch & Dent - Small / Front Bumper, Grille, Lamps - Scratch - Medium / (R) Front Door, Molding - Scratch & Dent - Small / (R) Front Fender, Molding - Scratch - Medium / (R) Center Panel - Scratch - Small</p>
