General Information

Make	Toyota	Model	Avanza
YOM	2025	Odo Meter Reading	26,746
Registration No.	NKE9421	Chassis No.	MHFAA1BY1R0029308
CC	1.3	Transmission	CVT
Fuel Type	Gas	Type of Body	MPV
Colour	Black

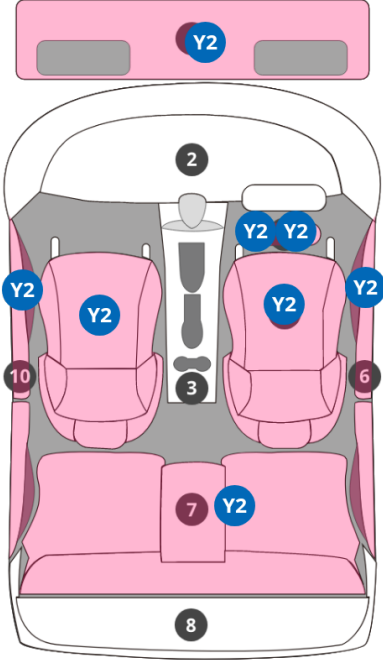
Interior Evaluation : B	Exterior Evaluation : D

<p>a : Cut, Fray d : Loose, Deformed k : Animal Hair s : Smell t : Cigarette Burns x : Defective y : Stain</p>

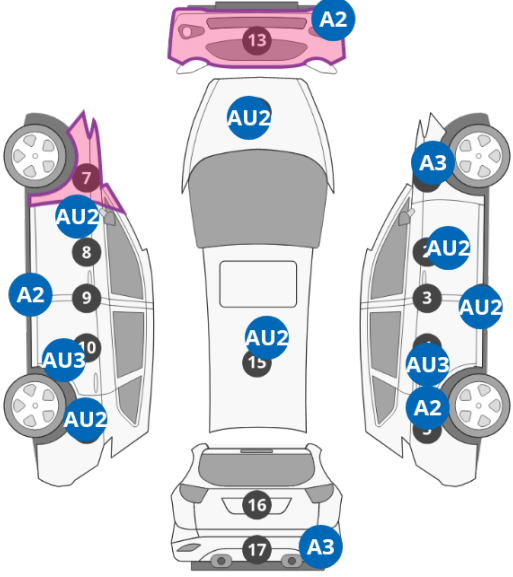
<p>A : Scratch AU : Scratch & Dent B : Modified C : Corrosion G : Stone chip P : Faded S : Rust SC : Rust & Corrosion U : Dent X : Defective Y : Crack, Gap</p>
Remarks (L) Front Seat - Grime - Small / (R) Front Seat - Grime - Small / Rear Seat - Grime - Small / (R) Front Floor Mat - Grime - Small / (L) Front Floor Mat - Grime - Small / (R) Front Trim - Grime - Small / (L) Front Trim - Grime - Small / Ceiling - Grime - Small	Remarks (L) Front Fender - Repair Traces - Yes / Front Bumper, Grille, Lamps - Repair mark - Yes / (L) Front Fender, Molding - Repair mark - Yes / Bonnet, Headlight - Scratch & Dent - Small / (R) Front Fender, Molding - Scratch - Medium / Front Bumper, Grille, Lamps - Scratch - Small / (L) Front Door, Molding - Scratch & Dent - Small / (L) Rear Door, Molding - Scratch & Dent - Medium / (L) Step, In-panel, Side Spoiler - Scratch - Small / (L) Rear Fender, Molding - Scratch & Dent - Small / Rear Bumper, Lamps, Panels - Scratch - Medium / (R) Rear Fender, Molding - Scratch - Small / (R) Rear Door, Molding - Scratch & Dent - Medium / (R) Front Door, Molding - Scratch & Dent - Small / Roof - Scratch & Dent - Small

Inspector Notes
with LTO plate, with spare tire, with jack, with reverse camera, no tools, no spare key, scratches on taillight and headlight.
