General Information

Make	Toyota	Model	Vios
YOM	2021	Odo Meter Reading	129,145
Registration No.	NEM6315	Chassis No.	PA1B18F37M4152138
CC	1.3	Transmission	CVT
Fuel Type	Gas	Type of Body	Sedan
Colour	Silver

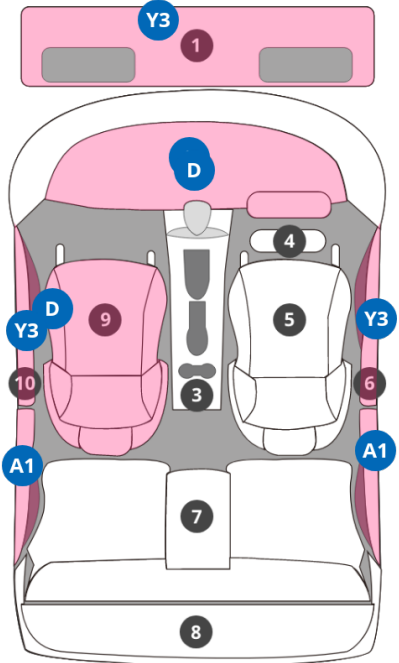
Interior Evaluation : C	Exterior Evaluation : E

<p>a : Cut, Fray d : Loose, Deformed k : Animal Hair s : Smell t : Cigarette Burns x : Defective y : Stain</p>

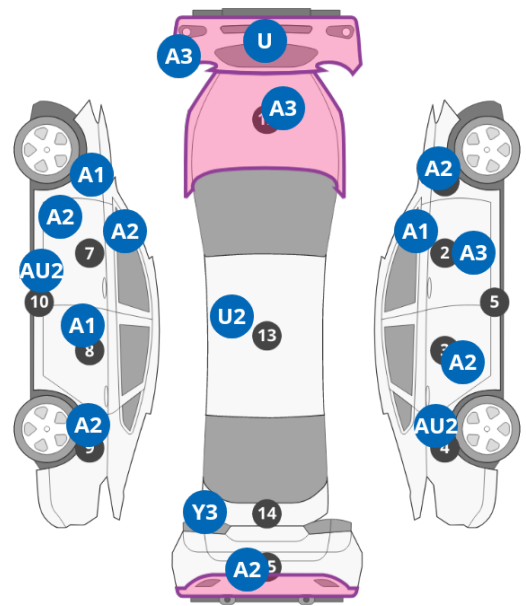
<p>A : Scratch AU : Scratch & Dent B : Modified C : Corrosion G : Stone chip P : Faded S : Rust SC : Rust & Corrosion U : Dent X : Defective Y : Crack, Gap</p>
<p>Remarks Overall Interior - Smell - Yes / Overall Interior - Worn as per age - Yes / (L) Front Seat - Worn - Yes / (R) Front Trim - Grime - Medium / (L) Front Trim - Grime - Medium / (R) Rear Trim - Cut, Crack - Minimal / (L) Rear Trim - Cut, Crack - Minimal / Ceiling - Grime - Medium / Dashboard - Traces of Adhesive Tape - Yes</p>	<p>Remarks Member (Bolted) - Dent - Yes / (R) Front Fender, Molding - Scratch - Small / (R) Front Door, Molding - Scratch - Medium / (R) Rear Door, Molding - Scratch - Small / (R) Mirror - Scratch - Minimal / (R) Rear Fender, Molding - Scratch & Dent - Small / Rear Bumper, Lamps, Panels - Repair mark - Yes / Rear Bumper, Lamps, Panels - Scratch - Small / (L) Rear Fender, Molding - Scratch - Small / (L) Step, In-panel, Side Spoiler - Scratch & Dent - Small / (L) Rear Door, Molding - Scratch - Minimal / (L) Front Door, Molding - Scratch - Small / (L) Mirror - Scratch - Small / (L) Front Fender, Molding - Scratch - Minimal / Front Bumper, Grille, Lamps - Scratch - Medium / Bonnet, Headlight - Repair mark - Yes / Front Bumper, Grille, Lamps - Repair mark - Yes / Bonnet, Headlight - Scratch - Medium / Roof - Dent - Small / Trunk Hood, Rear Gate - Crack, Gap - Medium</p>
