General Information

Make	Toyota	Model	Vios
YOM	2022	Odo Meter Reading	31,108
Registration No.	NID3469	Chassis No.	PA1B18F36N4184922
CC	1.3	Transmission	CVT
Fuel Type	Gas	Type of Body	Sedan
Colour	Black

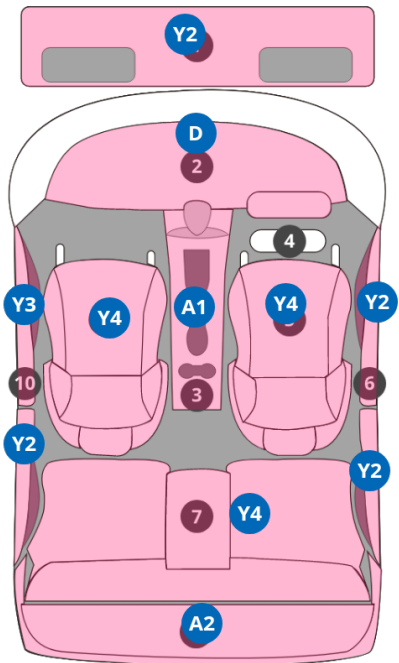
Interior Evaluation : D	Exterior Evaluation : E

<p>a : Cut, Fray d : Loose, Deformed k : Animal Hair s : Smell t : Cigarette Burns x : Defective y : Stain</p>

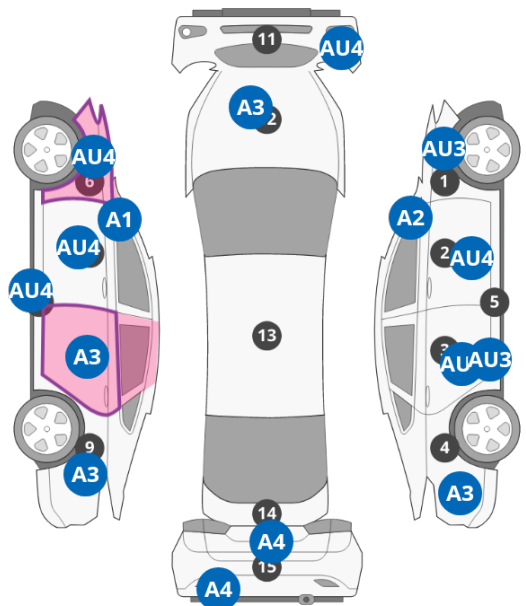
<p>A : Scratch AU : Scratch & Dent B : Modified C : Corrosion G : Stone chip P : Faded S : Rust SC : Rust & Corrosion U : Dent X : Defective Y : Crack, Gap</p>
Remarks (R) Front Seat - Grime - Large / (R) Front Trim - Grime - Small / Rear Seat - Grime - Large / (R) Rear Trim - Grime - Small / Trunk Room - Worn, Scratch, Cut, Crack - Small / (L) Rear Trim - Grime - Small / (L) Front Trim - Grime - Medium / (L) Front Seat - Grime - Large / Dashboard - Traces of Adhesive Tape - Yes / Ceiling - Grime - Small / Console, Switchs, Vents - Worn, Scratch, Cut, Crack - Minimal	Remarks (L) Front Fender - Repair Traces - Yes / (L) Rear Door - Repair Traces - Yes / (L) Front Fender, Molding - Repair mark - Yes / (L) Rear Door, Molding - Repair mark - Yes / (L) Front Fender, Molding - Scratch & Dent - Large / (L) Front Door, Molding - Scratch & Dent - Large / (L) Mirror - Scratch - Minimal / (L) Step, In-panel, Side Spoiler - Scratch & Dent - Large / (L) Rear Door, Molding - Scratch - Medium / (L) Rear Fender, Molding - Scratch - Medium / Trunk Hood, Rear Gate - Scratch - Large / Rear Bumper, Lamps, Panels - Scratch - Large / (R) Rear Fender, Molding - Scratch - Medium / (R) Rear Door, Molding - Scratch & Dent - Medium / (R) Step, In-panel, Side Spoiler - Scratch & Dent - Medium / (R) Front Door, Molding - Scratch & Dent - Large / (R) Mirror - Scratch - Small / (R) Front Fender, Molding - Scratch & Dent - Medium / Bonnet, Headlight - Scratch - Medium / Front Bumper, Grille, Lamps - Scratch & Dent - Large
