General Information

Make	Toyota	Model	Vios
YOM	2023	Odo Meter Reading	82,806
Registration No.	NIF5570	Chassis No.	PA1B18F37N4192365
CC	1.3	Transmission	CVT
Fuel Type	Gas	Type of Body	Sedan
Colour	Blue

Body / Panel Condition

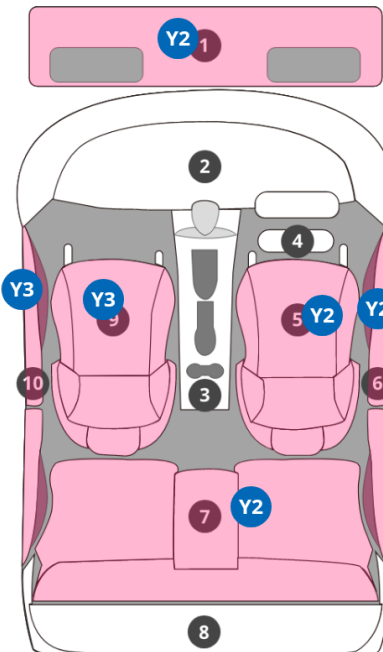
Interior Evaluation : B	Exterior Evaluation : E

<p>a : Cut, Fray d : Loose, Deformed k : Animal Hair s : Smell t : Cigarette Burns x : Defective y : Stain</p>

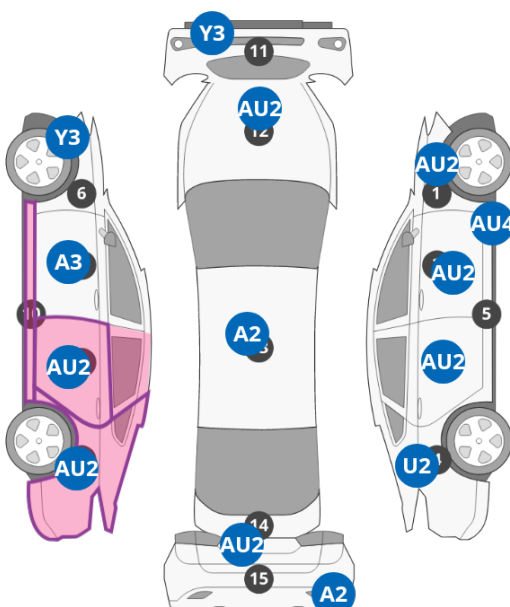
<p>A : Scratch AU : Scratch & Dent B : Modified C : Corrosion G : Stone chip P : Faded S : Rust SC : Rust & Corrosion U : Dent X : Defective Y : Crack, Gap</p>
<p>Remarks (L) Front Seat - Grime - Medium / (R) Front Seat - Grime - Small / (L) Front Trim - Grime - Medium / (R) Front Trim - Grime - Small / Rear Seat - Grime - Small / Ceiling - Grime - Small</p>	<p>Remarks (L) Rear Door - Repair Traces - Yes / (L) Rear Fender, Molding - Repair mark - Yes / (L) Rear Door, Molding - Repair mark - Yes / (L) Front Door, Molding - Scratch - Medium / (L) Rear Door, Molding - Scratch & Dent - Small / (L) Rear Fender, Molding - Scratch & Dent - Small / (L) Step, In-panel, Side Spoiler - Repair mark - Yes / Trunk Hood, Rear Gate - Scratch & Dent - Small / Rear Bumper, Lamps, Panels - Scratch - Small / Front Bumper, Grille, Lamps - Crack, Gap - Medium / Roof - Scratch - Small / (L) Front Fender, Molding - Crack, Gap - Medium / Bonnet, Headlight - Scratch & Dent - Small / (R) Front Fender, Molding - Scratch & Dent - Small / (R) Step, In-panel, Side Spoiler - Scratch & Dent - Large / (R) Front Door, Molding - Scratch & Dent - Small / (R) Rear Door, Molding - Scratch & Dent - Small / (R) Rear Fender, Molding - Dent - Small</p>
