General Information

Make	Toyota	Model	Hiace
YOM	2025	Odo Meter Reading	57,810
Registration No.	NKO1463	Chassis No.	JTFJT02P4S5039614
CC	3.0	Transmission	M/T
Fuel Type	Diesel	Type of Body	Van
Colour	Silver

Body / Panel Condition

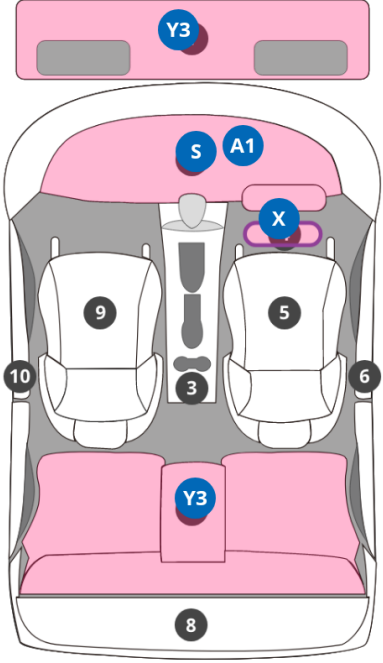
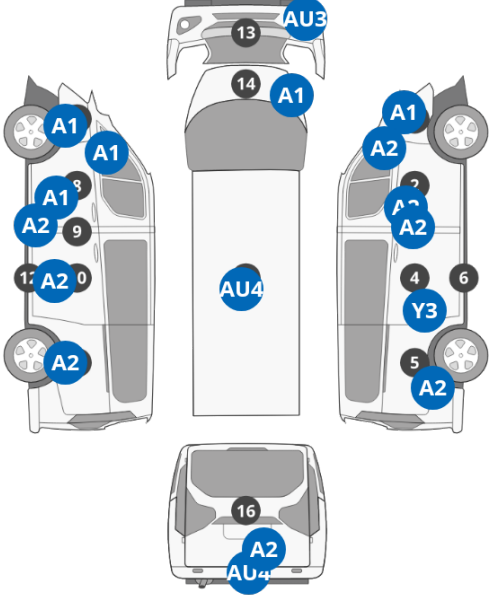
Interior Evaluation :	C	Exterior Evaluation :	E

<p>a : Cut, Fray d : Loose, Deformed k : Animal Hair s : Smell t : Cigarette Burns x : Defective y : Stain</p>		<p>A : Scratch AU : Scratch & Dent B : Modified C : Corrosion G : Stone chip P : Faded S : Rust SC : Rust & Corrosion U : Dent X : Defective Y : Crack, Gap</p>	
<p>Remarks Overall Interior - Worn as per age - Yes / Overall Interior - Smell - Yes / Rear Seat - Grime - Medium / Mat Other - Missing - Yes / Dashboard - Worn, Scratch, Cut, Crack - Minimal / Ceiling - Grime - Medium</p>		<p>Remarks Roof - Repair Traces - Yes / (R) Front Fender, Molding - Scratch - Minimal / (R) Mirror - Scratch - Small / (R) Front Door, Molding - Scratch - Small / (R) Center Panel - Scratch - Small / (R) Rear Door, Molding - Crack, Gap - Medium / (R) Rear Fender, Molding - Scratch - Small / Rear Bumper, Lamps, Panels - Scratch & Dent - Large / Trunk Hood, Rear Gate - Scratch - Small / (L) Rear Fender, Molding - Scratch - Small / (L) Center Panel - Scratch - Small / (L) Rear Door, Molding - Scratch - Small / (L) Front Door, Molding - Scratch - Minimal / (L) Mirror - Scratch - Minimal / (L) Front Fender, Molding - Scratch - Minimal / Front Bumper, Grille, Lamps - Scratch & Dent - Medium / Front Panel - Scratch - Minimal / Roof - Scratch & Dent - Large</p>

Inspector Notes
with warranty booklet, with jack and tools, with spare tire, with LTO plate, scratches on headlight and tail light, cracked fog lamps
