General Information

Make	Toyota	Model	Vios
YOM	2020	Odo Meter Reading	70,237
Registration No.	DAT2456	Chassis No.	PA1B18F33L4116493
CC	1.3	Transmission	CVT
Fuel Type	Gas	Type of Body	Sedan
Colour	Silver

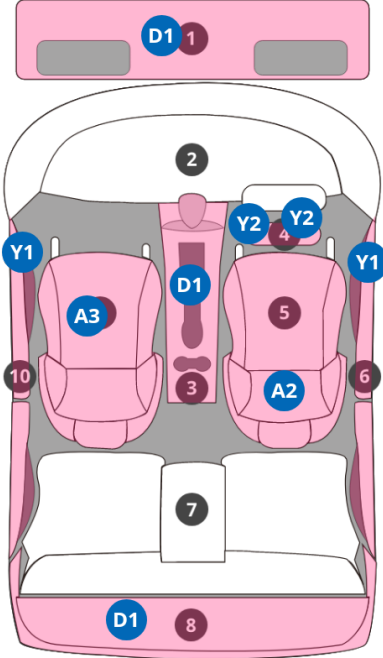
Interior Evaluation : B	Exterior Evaluation : E

<p>a : Cut, Fray d : Loose, Deformed k : Animal Hair s : Smell t : Cigarette Burns x : Defective y : Stain</p>

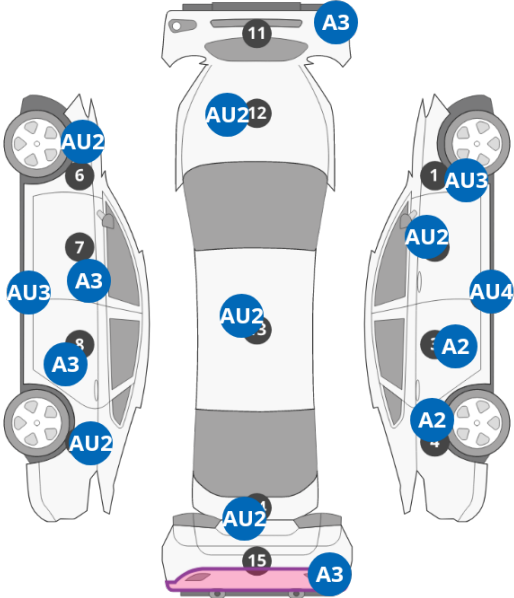
<p>A : Scratch AU : Scratch & Dent B : Modified C : Corrosion G : Stone chip P : Faded S : Rust SC : Rust & Corrosion U : Dent X : Defective Y : Crack, Gap</p>
Remarks (R) Front Seat - Cut, Crack - Small / (L) Front Seat - Cut, Crack - Medium / (R) Front Floor Mat - Grime - Small / (L) Front Floor Mat - Grime - Small / Ceiling - Crinkle - Minimal / (L) Front Trim - Grime - Minimal / (R) Rear Trim - Grime - Minimal / Trunk Room - Worked - Minimal / Console, Switchs, Vents - Worked - Minimal	Remarks (R) Front Fender - Repair Traces - Yes / Bonnet - Repair Traces - Yes / (L) Front Door, Molding - Scratch - Medium / (L) Rear Door, Molding - Scratch - Medium / (L) Rear Fender, Molding - Scratch & Dent - Small / (L) Step, In-panel, Side Spoiler - Scratch & Dent - Medium / Rear Bumper, Lamps, Panels - Repair mark - Yes / Rear Bumper, Lamps, Panels - Scratch - Medium / Trunk Hood, Rear Gate - Scratch & Dent - Small / (R) Rear Fender, Molding - Scratch - Small / (R) Rear Door, Molding - Scratch - Small / (R) Step, In-panel, Side Spoiler - Scratch & Dent - Large / (R) Front Door, Molding - Scratch & Dent - Small / (R) Front Fender, Molding - Scratch & Dent - Medium / Bonnet, Headlight - Scratch & Dent - Small / Front Bumper, Grille, Lamps - Scratch - Medium / (L) Front Fender, Molding - Scratch & Dent - Small / Roof - Scratch & Dent - Small
