General Information

Make	Toyota	Model	Vios
YOM	2021	Odo Meter Reading	31,977
Registration No.	NGT3905 - with MMDA Apprehension	Chassis No.	PA1B18F33M4135093
CC	1.3	Transmission	CVT
Fuel Type	Gas	Type of Body	Sedan
Colour	Silver

Overall Evaluation :

B

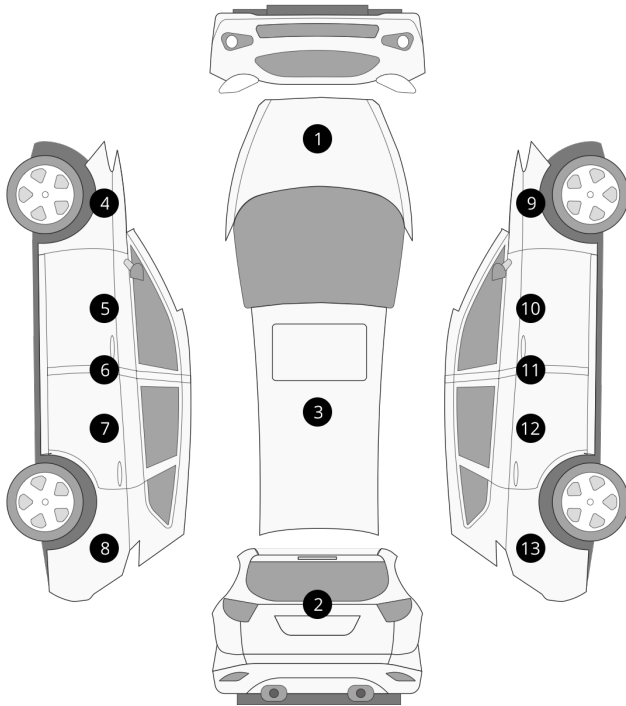
Body / Panel Condition

#	Area	Thickness(um)			
		Average	Value1	Value2	Value3/4
1	Bonnet	116.0	115	107	126
2	Boot Lid	121.3	120	116	128
3	Roof	100.4	109	102	93/98
4	Left Front Fender	104.0	106	102	104
5	Left Front Door	104.3	116	103	94
6	Center Panel Left				
7	Left Rear Door	108.3	111	106	108
8	Left Back Panel	109.3	102	110	116
9	Right Front Fender	107.0	101	105	115
10	Right Front Door	99.0	97	100	100
11	Center Panel Right				
12	Right Rear Door	106.6	103	109	108
13	Right Back Panel	103.5	101	100	110

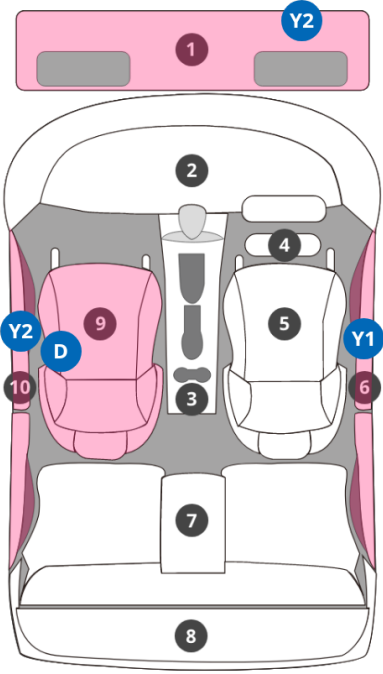
<p>a : Cut, Fray d : Loose, Deformed k : Animal Hair s : Smell t : Cigarette Burns x : Defective y : Stain</p>

<p>A : Scratch AU : Scratch & Dent B : Modified C : Corrosion G : Stone chip P : Faded S : Rust SC : Rust & Corrosion U : Dent X : Defective Y : Crack, Gap</p>
<p>Remarks Overall Interior - Worn as per age - Yes / (L) Front Trim - Grime - Small / (R) Front Trim - Grime - Minimal / Ceiling - Grime - Small / (L) Front Seat - Worn - Yes</p>	<p>Remarks Member (Bolted) - Dent - Yes / (R) Mirror - Scratch - Minimal / (R) Front Fender, Molding - Scratch - Minimal / (R) Step, In-panel, Side Spoiler - Scratch - Minimal / (R) Front Door, Molding - Scratch - Minimal / (R) Rear Door, Molding - Scratch - Minimal / (R) Rear Fender, Molding - Scratch - Minimal / Trunk Hood, Rear Gate - Scratch - Small / (L) Rear Fender, Molding - Repair mark - Yes / Rear Bumper, Lamps, Panels - Scratch & Dent - Medium / (L) Rear Fender, Molding - Scratch - Small / (L) Rear Door, Molding - Scratch - Small / (L) Front Door, Molding - Scratch - Small / (L) Mirror - Scratch - Small / (L) Front Fender, Molding - Scratch - Minimal / Front Bumper, Grille, Lamps - Scratch - Small / Bonnet, Headlight - Scratch - Medium / Roof - Scratch - Minimal</p>
