General Information

Make	Toyota	Model	Wigo
YOM	2023	Odo Meter Reading	35,157
Registration No.	VAB5236L	Chassis No.	MHKA4DF5FNJ078020
CC	1.0	Transmission	A/T
Fuel Type	Gas	Type of Body	Hatchback
Colour	Silver

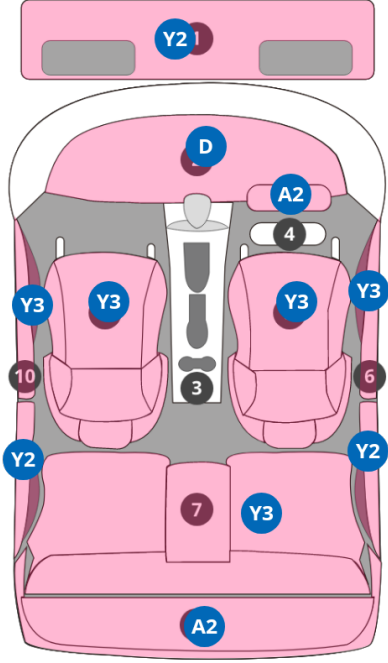
Interior Evaluation : D	Exterior Evaluation : E

<p>a : Cut, Fray d : Loose, Deformed k : Animal Hair s : Smell t : Cigarette Burns x : Defective y : Stain</p>

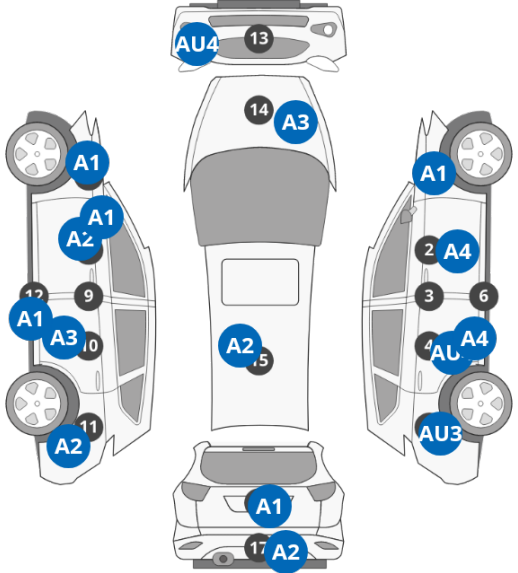
<p>A : Scratch AU : Scratch & Dent B : Modified C : Corrosion G : Stone chip P : Faded S : Rust SC : Rust & Corrosion U : Dent X : Defective Y : Crack, Gap</p>
Remarks (L) Front Trim - Grime - Medium / (L) Front Seat - Grime - Medium / (R) Front Seat - Grime - Medium / (R) Front Trim - Grime - Medium / Dashboard - Traces of Adhesive Tape - Yes / Rear Seat - Grime - Medium / (R) Rear Trim - Grime - Small / (L) Rear Trim - Grime - Small / Steering Wheel - Worn, Peel, Crack - Small / Ceiling - Grime - Small / Trunk Room - Worn, Scratch, Cut, Crack - Small	Remarks Rear Bumper, Lamps, Panels - Scratch - Small / Trunk Hood, Rear Gate - Scratch - Minimal / (L) Rear Door, Molding - Scratch - Medium / (L) Rear Fender, Molding - Scratch - Small / (L) Step, In-panel, Side Spoiler - Scratch - Minimal / (L) Front Door, Molding - Scratch - Small / (L) Mirror - Scratch - Minimal / (L) Front Fender, Molding - Scratch - Minimal / Front Bumper, Grille, Lamps - Scratch & Dent - Large / Bonnet, Headlight - Scratch - Medium / (R) Front Fender, Molding - Scratch - Minimal / (R) Front Door, Molding - Scratch - Large / (R) Rear Door, Molding - Scratch & Dent - Large / (R) Rear Fender, Molding - Scratch & Dent - Medium / (R) Step, In-panel, Side Spoiler - Scratch - Large / Roof - Scratch - Small
