General Information

| Make | Toyota | Model | Vios |
| YOM | 2022 | Odo Meter Reading | 187,288 |
| Registration No. | DAQ6200 | Chassis No. | PA1B18F36N4177789 |

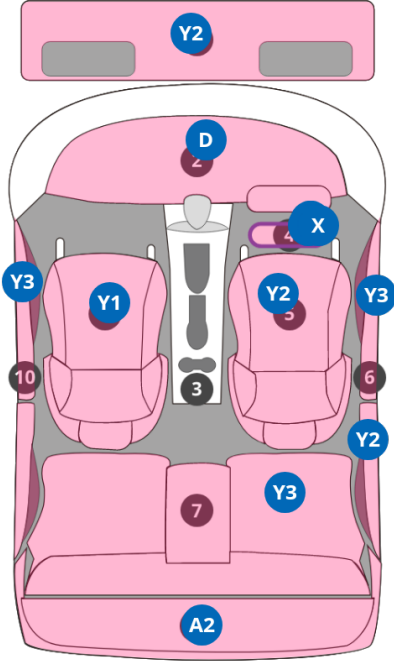
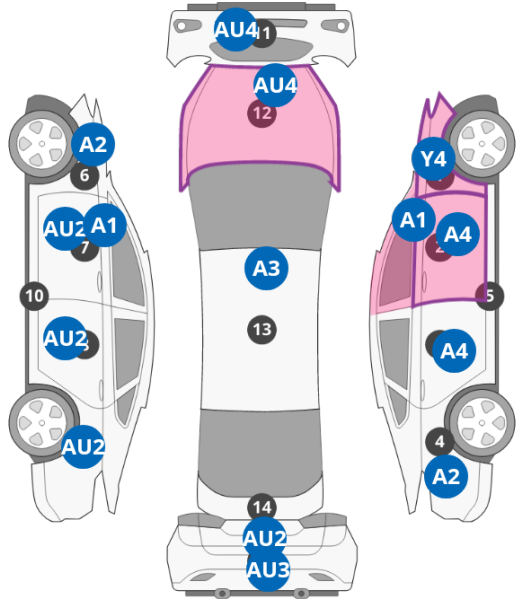
| Interior Evaluation : C | Exterior Evaluation : E |

| <p>a : Cut, Fray d : Loose, Deformed k : Animal Hair s : Smell t : Cigarette Burns x : Defective y : Stain</p> | <p>A : Scratch AU : Scratch & Dent B : Modified C : Corrosion G : Stone chip P : Faded S : Rust SC : Rust & Corrosion U : Dent X : Defective Y : Crack, Gap</p> |
| <p>Remarks (R) Front Seat - Grime - Small / (R) Front Trim - Grime - Medium / Rear Seat - Grime - Medium / Trunk Room - Worn, Scratch, Cut, Crack - Small / (R) Rear Trim - Grime - Small / (L) Front Trim - Grime - Medium / (L) Front Seat - Grime - Minimal / (R) Front Floor Mat - Missing - Yes / (L) Front Floor Mat - Missing - Yes / Mat Other - Missing - Yes / Ceiling - Grime - Small / Dashboard - Traces of Adhesive Tape - Yes</p> | <p>Remarks (R) Front Door - Repair Traces - Yes / (R) Front Fender - Repair Traces - Yes / Bonnet - Repair Traces - Yes / (L) Front Fender - Repair Traces - Yes / (L) Front Door - Repair Traces - Yes / (L) Rear Door - Repair Traces - Yes / (L) Rear Fender - Repair Traces - Yes / Trunk Hood, Rear Gate - Repair Traces - Yes / (R) Rear Fender - Repair Traces - Yes / (R) Rear Door - Repair Traces - Yes / Roof - Repair Traces - Yes / Bonnet, Headlight - Repair mark - Yes / (R) Front Fender, Molding - Repair mark - Yes / (R) Front Door, Molding - Repair mark - Yes / (L) Rear Fender, Molding - Scratch & Dent - Small / (L) Rear Door, Molding - Scratch & Dent - Small / (L) Front Door, Molding - Scratch & Dent - Small / (L) Front Fender, Molding - Scratch - Small / (L) Mirror - Scratch - Minimal / Bonnet, Headlight - Scratch & Dent - Large / Front Bumper, Grille, Lamps - Scratch & Dent - Large / (R) Front Fender, Molding - Crack, Gap - Large / (R) Mirror - Scratch - Minimal / (R) Front Door, Molding - Scratch - Large / (R) Rear Door, Molding - Scratch - Large / (R) Rear Fender, Molding - Scratch - Small / Rear Bumper, Lamps, Panels - Scratch & Dent - Medium / Trunk Hood, Rear Gate - Scratch & Dent - Small / Roof - Scratch - Medium</p> |
