## General Information

<b>Make</b>	Toyota	<b>Model</b>	Raize
<b>YOM</b>	2023	<b>Odo Meter Reading</b>	45,510
<b>Registration No.</b>	DBG1322	<b>Chassis No.</b>	MHKAB1BA6NJ030282
<b>CC</b>	1.2	<b>Transmission</b>	CVT
<b>Fuel Type</b>	Gas	<b>Type of Body</b>	SUV
<b>Colour</b>	Red

## Body / Panel Condition

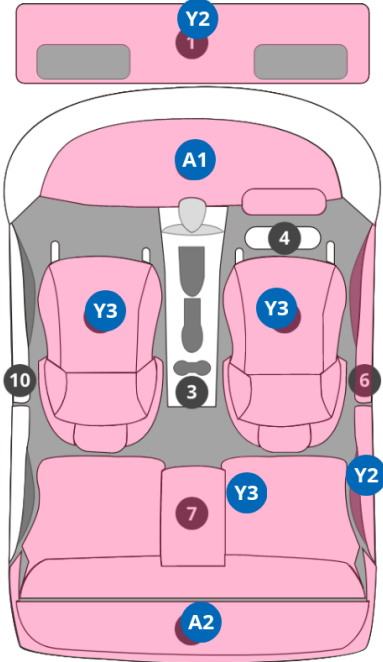
<b>Interior Evaluation :</b> <span style="float: right; color: red; font-weight: bold;">C</span>	<b>Exterior Evaluation :</b> <span style="float: right; color: red; font-weight: bold;">E</span>

<p><b>a</b> : Cut, Fray <b>d</b> : Loose, Deformed <b>k</b> : Animal Hair <b>s</b> : Smell <b>t</b> : Cigarette Burns <b>x</b> : Defective <b>y</b> : Stain</p>

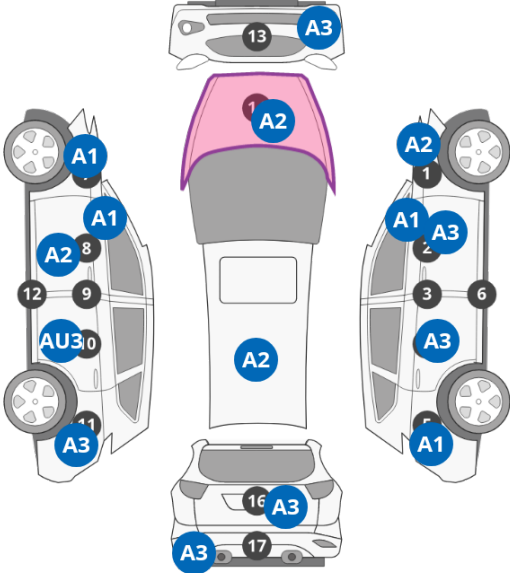
<p><b>A</b> : Scratch <b>AU</b> : Scratch &amp; Dent <b>B</b> : Modified <b>C</b> : Corrosion <b>G</b> : Stone chip <b>P</b> : Faded <b>S</b> : Rust <b>SC</b> : Rust &amp; Corrosion <b>U</b> : Dent <b>X</b> : Defective <b>Y</b> : Crack, Gap</p>
<p><b>Remarks</b> (R) Front Seat - Grime - Medium / Rear Seat - Grime - Medium / (R) Rear Trim - Grime - Small / Trunk Room - Worn, Scratch, Cut, Crack - Small / (L) Front Seat - Grime - Medium / Ceiling - Grime - Small / Dashboard - Worn, Scratch, Cut, Crack - Minimal</p>	<p><b>Remarks</b> Bonnet - Repair Traces - Yes / (L) Rear Door - Repair Traces - Yes / Bonnet, Headlight - Repair mark - Difference in Color / (L) Front Fender, Molding - Scratch - Minimal / (R) Front Fender, Molding - Scratch - Small / Front Bumper, Grille, Lamps - Scratch - Medium / (R) Mirror - Scratch - Minimal / (R) Front Door, Molding - Scratch - Medium / (R) Rear Door, Molding - Scratch - Medium / (R) Rear Fender, Molding - Scratch - Minimal / Trunk Hood, Rear Gate - Scratch - Medium / Rear Bumper, Lamps, Panels - Scratch - Medium / (L) Rear Fender, Molding - Scratch - Medium / (L) Rear Door, Molding - Scratch &amp; Dent - Medium / (L) Mirror - Scratch - Minimal / (L) Front Door, Molding - Scratch - Small / Bonnet, Headlight - Scratch - Small / Roof - Scratch - Small</p>
