General Information

Make	Toyota	Model	Innova
YOM	2025	Odo Meter Reading	31,718
Registration No.	DBR8573	Chassis No.	PA2JA8EM9R0152089
CC	2.8	Transmission	A/T
Fuel Type	Diesel	Type of Body	Wagon
Colour	Red

Body / Panel Condition

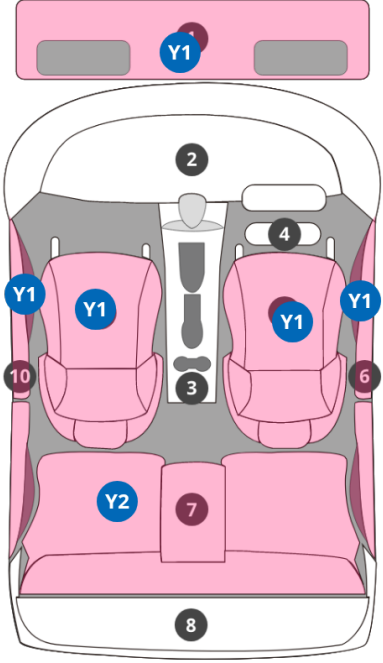
<p>a : Cut, Fray d : Loose, Deformed k : Animal Hair s : Smell t : Cigarette Burns x : Defective y : Stain</p>

<p>A : Scratch AU : Scratch & Dent B : Modified C : Corrosion G : Stone chip P : Faded S : Rust SC : Rust & Corrosion U : Dent X : Defective Y : Crack, Gap</p>
<p>Remarks (L) Front Seat - Grime - Minimal / (R) Front Seat - Grime - Minimal / Rear Seat - Grime - Small / (L) Front Trim - Grime - Minimal / (R) Front Trim - Grime - Minimal / Ceiling - Grime - Minimal</p>	<p>Remarks (L) Front Fender, Molding - Scratch & Dent - Small / (L) Front Door, Molding - Scratch & Dent - Small / (L) Rear Door, Molding - Scratch & Dent - Minimal / (L) Rear Fender, Molding - Scratch & Dent - Small / (L) Step, In-panel, Side Spoiler - Scratch & Dent - Small / Rear Bumper, Lamps, Panels - Scratch & Dent - Small / (R) Rear Fender, Molding - Scratch & Dent - Small / (R) Rear Door, Molding - Scratch & Dent - Small / (R) Front Door, Molding - Scratch & Dent - Small / (R) Front Fender, Molding - Scratch & Dent - Small / Bonnet, Headlight - Scratch & Dent - Small / Front Bumper, Grille, Lamps - Scratch & Dent - Small / Roof - Scratch & Dent - Small</p>

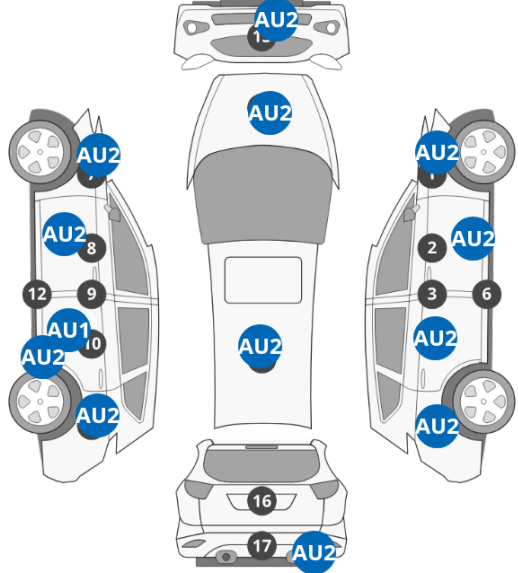
<p>Inspector Notes</p>
<p>with LTO plate, with spare tire, with reverse camera, with manual and warranty booklet, scratches on taillight and headlight.</p>
