General Information

Make	Toyota	Model	Vios
YOM	2022	Odo Meter Reading	106,730
Registration No.	NFH1440	Chassis No.	PA1B18F35M4162540
CC	1.3	Transmission	CVT
Fuel Type	Gas	Type of Body	Sedan
Colour	Red Mica Metallic

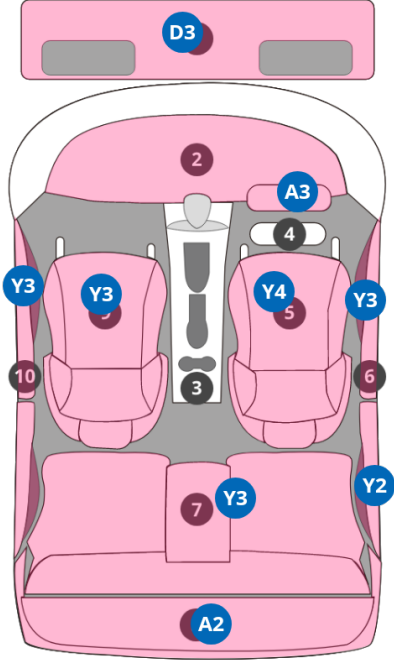
Interior Evaluation : D	Exterior Evaluation : E

<p>a : Cut, Fray d : Loose, Deformed k : Animal Hair s : Smell t : Cigarette Burns x : Defective y : Stain</p>

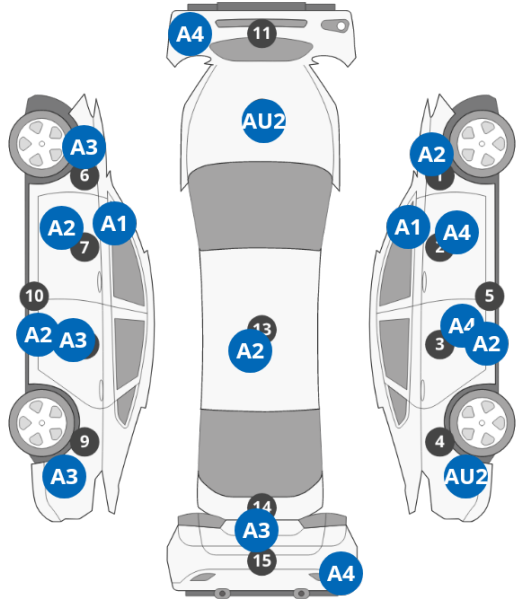
<p>A : Scratch AU : Scratch & Dent B : Modified C : Corrosion G : Stone chip P : Faded S : Rust SC : Rust & Corrosion U : Dent X : Defective Y : Crack, Gap</p>
<p>Remarks (R) Front Seat - Grime - Large / (R) Front Trim - Grime - Medium / Rear Seat - Grime - Medium / (R) Rear Trim - Grime - Small / Trunk Room - Worn, Scratch, Cut, Crack - Small / (L) Front Trim - Grime - Medium / (L) Front Seat - Grime - Medium / Steering Wheel - Worn, Peel, Crack - Medium / Ceiling - Loose, Deformed - Medium</p>	<p>Remarks Front Bumper, Grille, Lamps - Scratch - Large / (L) Front Fender, Molding - Scratch - Medium / (L) Front Door, Molding - Scratch - Small / (L) Mirror - Scratch - Minimal / (L) Rear Door, Molding - Scratch - Medium / (L) Step, In-panel, Side Spoiler - Scratch - Small / (L) Rear Fender, Molding - Scratch - Medium / Trunk Hood, Rear Gate - Scratch - Medium / Rear Bumper, Lamps, Panels - Scratch - Large / (R) Rear Fender, Molding - Scratch & Dent - Small / (R) Rear Door, Molding - Scratch - Large / (R) Step, In-panel, Side Spoiler - Scratch - Small / (R) Front Door, Molding - Scratch - Large / (R) Front Fender, Molding - Scratch - Small / (R) Mirror - Scratch - Minimal / Bonnet, Headlight - Scratch & Dent - Small / Roof - Scratch - Small</p>
