General Information

Make	Toyota	Model	Lite Ace
YOM	2024	Odo Meter Reading	16,165
Registration No.	NFR4332	Chassis No.	MHKB3FE10RK003771
CC	1.5	Transmission	M/T
Fuel Type	Gas	Type of Body	Utility Cargo
Colour	White

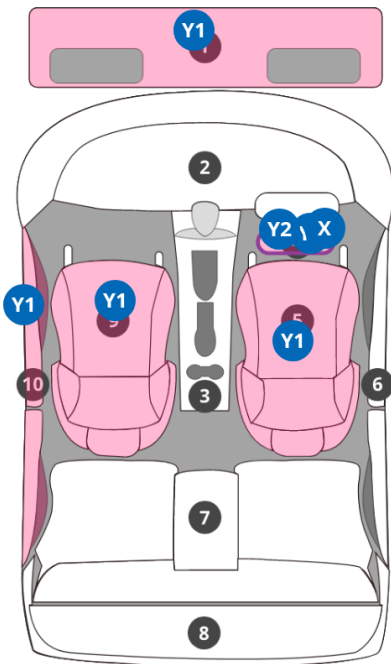
Interior Evaluation : B	Exterior Evaluation : D

<p>a : Cut, Fray d : Loose, Deformed k : Animal Hair s : Smell t : Cigarette Burns x : Defective y : Stain</p>

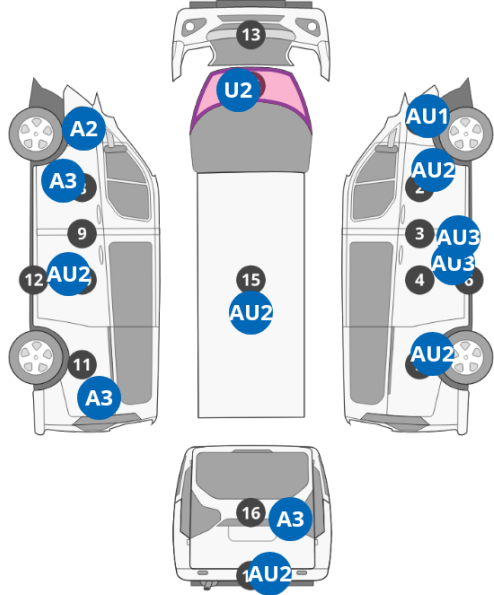
<p>A : Scratch AU : Scratch & Dent B : Modified C : Corrosion G : Stone chip P : Faded S : Rust SC : Rust & Corrosion U : Dent X : Defective Y : Crack, Gap</p>
<p>Remarks (L) Front Seat - Grime - Minimal / (R) Front Seat - Grime - Minimal / (R) Front Floor Mat - Grime - Small / (L) Front Floor Mat - Grime - Small / Mat Other - Missing - Yes / Ceiling - Grime - Minimal / (L) Front Trim - Grime - Minimal</p>	<p>Remarks (L) Front Door, Molding - Scratch - Medium / Front Panel - Repair mark - Yes / Front Panel - Dent - Small / (R) Front Fender, Molding - Scratch & Dent - Minimal / (R) Front Door, Molding - Scratch & Dent - Small / (R) Rear Door, Molding - Scratch & Dent - Medium / (R) Step, In-panel, Side Spoiler - Scratch & Dent - Medium / (R) Rear Fender, Molding - Scratch & Dent - Small / Trunk Hood, Rear Gate - Scratch - Medium / Rear Bumper, Lamps, Panels - Scratch & Dent - Small / (L) Rear Fender, Molding - Scratch - Medium / (L) Rear Door, Molding - Scratch & Dent - Small / (L) Front Fender, Molding - Scratch - Small / Roof - Scratch & Dent - Small</p>

<p>Inspector Notes</p>
<p>with LTO plate, with spare tire, with jack, with manual booklet, issue on left side taillight, scratches on taillight and headlight.</p>
