General Information

Make	Toyota	Model	Avanza
YOM	2024	Odo Meter Reading	13,613
Registration No.	NHM2377	Chassis No.	MHFAA1BY9P0020983
CC	1.3	Transmission	CVT
Fuel Type	Gas	Type of Body	MPV
Colour	Red Mica Metallic

Body / Panel Condition

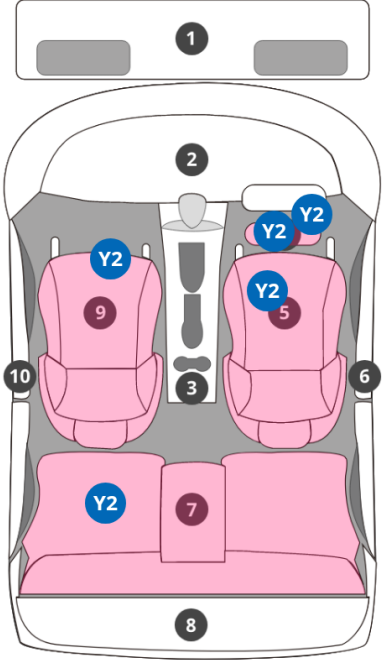
Interior Evaluation : B	Exterior Evaluation : D

<p>a : Cut, Fray d : Loose, Deformed k : Animal Hair s : Smell t : Cigarette Burns x : Defective y : Stain</p>

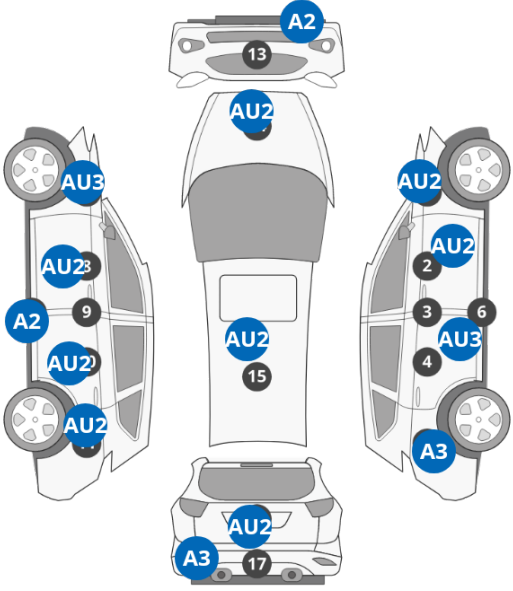
<p>A : Scratch AU : Scratch & Dent B : Modified C : Corrosion G : Stone chip P : Faded S : Rust SC : Rust & Corrosion U : Dent X : Defective Y : Crack, Gap</p>
<p>Remarks (L) Front Floor Mat - Grime - Small / (R) Front Floor Mat - Grime - Small / (L) Front Seat - Grime - Small / (R) Front Seat - Grime - Small / Rear Seat - Grime - Small</p>	<p>Remarks (L) Front Fender, Molding - Scratch & Dent - Medium / Bonnet, Headlight - Scratch & Dent - Small / Front Bumper, Grille, Lamps - Scratch - Small / (R) Front Fender, Molding - Scratch & Dent - Small / (R) Front Door, Molding - Scratch & Dent - Small / (R) Rear Door, Molding - Scratch & Dent - Medium / (R) Rear Fender, Molding - Scratch - Medium / Rear Bumper, Lamps, Panels - Scratch - Medium / Trunk Hood, Rear Gate - Scratch & Dent - Small / (L) Rear Fender, Molding - Scratch & Dent - Small / (L) Rear Door, Molding - Scratch & Dent - Small / (L) Front Door, Molding - Scratch & Dent - Small / (L) Center Panel - Scratch - Small / Roof - Scratch & Dent - Small</p>

<p>Inspector Notes</p>
<p>with LTO plate, with Manual and warranty booklet, with jack, with reverse camera, scratches on taillight and headlight.</p>
