General Information

Make	Toyota	Model	Rush
YOM	2021	Odo Meter Reading	53,080
Registration No.	NEP6878	Chassis No.	MHKE8FF3PMK032238
CC	1.5	Transmission	A/T
Fuel Type	Gas	Type of Body	SUV
Colour	Red Mica Metallic

Body / Panel Condition

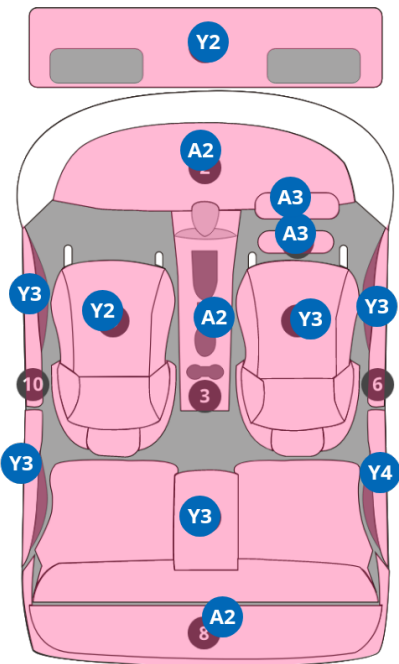
Interior Evaluation : E	Exterior Evaluation : E

<p>a : Cut, Fray d : Loose, Deformed k : Animal Hair s : Smell t : Cigarette Burns x : Defective y : Stain</p>

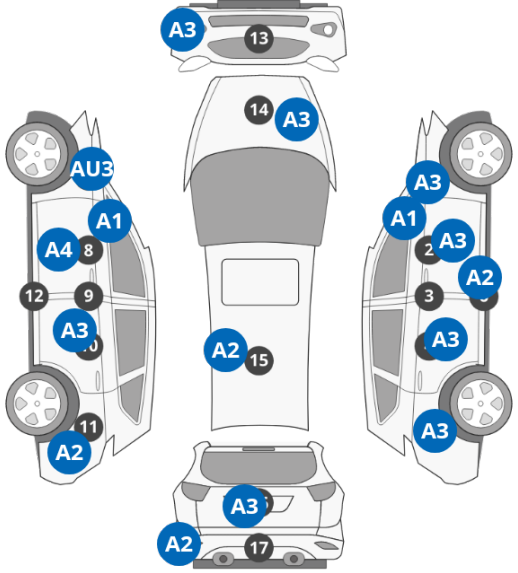
<p>A : Scratch AU : Scratch & Dent B : Modified C : Corrosion G : Stone chip P : Faded S : Rust SC : Rust & Corrosion U : Dent X : Defective Y : Crack, Gap</p>
<p>Remarks (R) Front Seat - Grime - Medium / (R) Front Trim - Grime - Medium / (R) Rear Trim - Grime - Large / Rear Seat - Grime - Medium / Trunk Room - Worn, Scratch, Cut, Crack - Small / (L) Rear Trim - Grime - Medium / (L) Front Trim - Grime - Medium / (L) Front Seat - Grime - Small / (L) Front Floor Mat - Cut, Crack - Medium / Steering Wheel - Worn, Peel, Crack - Medium / Ceiling - Grime - Small / Dashboard - Worn, Scratch, Cut, Crack - Small / Console, Switches, Vents - Worn, Scratch, Cut, Crack - Small</p>	<p>Remarks (L) Front Fender, Molding - Scratch & Dent - Medium / (L) Mirror - Scratch - Minimal / (L) Front Door, Molding - Scratch - Large / (L) Rear Door, Molding - Scratch - Medium / (L) Rear Fender, Molding - Scratch - Small / Bonnet, Headlight - Scratch - Medium / Front Bumper, Grille, Lamps - Scratch - Medium / (R) Front Fender, Molding - Scratch - Medium / (R) Mirror - Scratch - Minimal / (R) Front Door, Molding - Scratch - Medium / (R) Step, In-panel, Side Spoiler - Scratch - Small / (R) Rear Door, Molding - Scratch - Medium / (R) Rear Fender, Molding - Scratch - Medium / Rear Bumper, Lamps, Panels - Scratch - Small / Trunk Hood, Rear Gate - Scratch - Medium / Roof - Scratch - Small</p>
