## General Information

| Make | Toyota | Model | Vios |
| YOM | 2022 | Mileage | 69,193 |
| Registration No. | DAQ9208 | Chassis No. | PA1B18F30N4179487 |

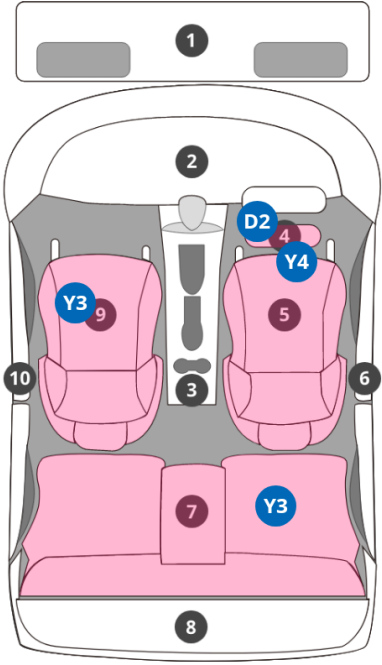
| Interior Evaluation : <span style="color: red; font-weight: bold;">C</span> | Exterior Evaluation : <span style="color: red; font-weight: bold;">C</span> |
|---|---|
| <b>Remarks</b><br>(R) Front Seat - Grime - Large / (L) Front Seat - Grime - Medium / (L) Front Floor Mat - Worked - Small / Rear Seat - Grime - Medium | <b>Remarks</b><br>(R) Front Door - Repair Traces - Yes / (R) Step - Repair Traces - Yes / (R) Front Fender - Repair Traces - Yes / Bonnet - Repair Traces - Yes / (L) Front Fender - Repair Traces - Yes / (L) Step - Repair Traces - Yes / (L) Rear Fender - Repair Traces - Yes / (R) Rear Fender - Repair Traces - Yes / (R) Rear Door - Repair Traces - Yes / Member (Bolted) - Dent - Yes / (R) Rear Fender, Molding - Dent - Small / Trunk Hood, Rear Gate - Dent - Small / Rear Bumper, Lamps, Panels - Scratch - Medium / (R) Step, In-panel, Side Spoiler - Scratch & Dent - Medium / (L) Front Door, Molding - Scratch & Dent - Small / Front Bumper, Grille, Lamps - Scratch - Medium / (R) Mirror - Scratch - Minimal |
