General Information

Make	Toyota	Model	Innova
YOM	2007	Odo Meter Reading	192,838
Registration No.	ZLT704	Chassis No.	TGN405011117
CC	2.5	Transmission	A/T
Fuel Type	Gas	Type of Body	Wagon
Colour	Black

Body / Panel Condition

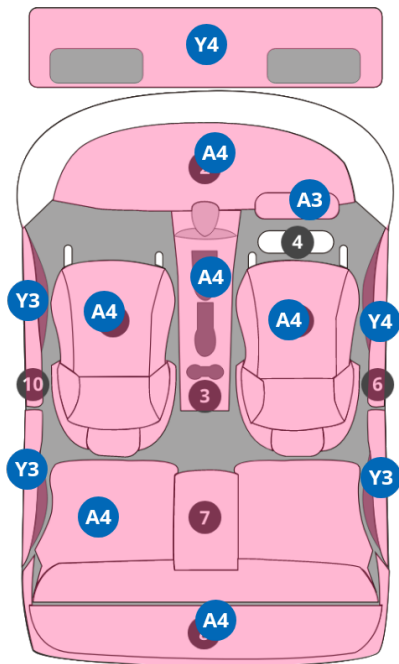
Interior Evaluation : E	Exterior Evaluation : E

<p>a : Cut, Fray d : Loose, Deformed k : Animal Hair s : Smell t : Cigarette Burns x : Defective y : Stain</p>

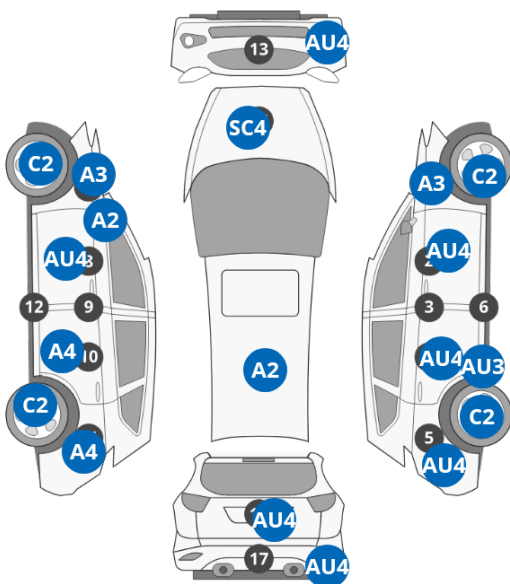
<p>A : Scratch AU : Scratch & Dent B : Modified C : Corrosion G : Stone chip P : Faded S : Rust SC : Rust & Corrosion U : Dent X : Defective Y : Crack, Gap</p>
<p>Remarks (L) Front Seat - Cut, Crack - Large / Steering Wheel - Worn, Peel, Crack - Medium / (L) Front Trim - Grime - Medium / (L) Rear Trim - Grime - Medium / Rear Seat - Cut, Crack - Large / Trunk Room - Worn, Scratch, Cut, Crack - Large / (R) Front Trim - Grime - Large / (R) Rear Trim - Grime - Medium / Dashboard - Worn, Scratch, Cut, Crack - Large / (R) Front Seat - Cut, Crack - Large / Console, Switches, Vents - Worn, Scratch, Cut, Crack - Large / Ceiling - Grime - Large</p>	<p>Remarks (R) Front Fender - Repair Traces - Yes / Bonnet - Repair Traces - Yes / (L) Front Fender - Repair Traces - Yes / (L) Front Door - Repair Traces - Yes / Trunk Hood, Rear Gate - Repair Traces - Yes / (R) Rear Fender - Repair Traces - Yes / Roof - Repair Traces - Yes / (R) Front Fender, Molding - Scratch - Medium / Front Bumper, Grille, Lamps - Scratch & Dent - Large / Bonnet, Headlight - Rust, Corrosion - Large / (L) Front Fender, Molding - Scratch - Medium / (L) Mirror - Scratch - Small / (L) Front Door, Molding - Scratch & Dent - Large / (L) Rear Door, Molding - Scratch - Large / (L) Rear Fender, Molding - Scratch - Large / Rear Bumper, Lamps, Panels - Scratch & Dent - Large / Trunk Hood, Rear Gate - Scratch & Dent - Large / (R) Rear Fender, Molding - Scratch & Dent - Large / (R) Rear Door, Molding - Scratch & Dent - Large / (R) Front Door, Molding - Scratch & Dent - Large / (R) Step, In-panel, Side Spoiler - Scratch & Dent - Medium / Roof - Scratch - Small / (R) Rear Wheel, Cover - Scratch, Corrosion - Small / (R) Front Wheel, Cover - Scratch, Corrosion - Small / (L) Rear Wheel, Cover - Scratch, Corrosion - Small / (L) Front Wheel, Cover - Scratch, Corrosion - Small</p>
