General Information

Date & Time: 27, Jan, 2026 20:03

Make	Toyota	Model	Hilux
YOM	2024	Odo Meter Reading	65,855
Registration No.	FAR8139	Chassis No.	MR0JB8DD4R3551720
CC	2.4	Transmission	M/T
Fuel Type	Diesel	Type of Body	Pickup
Colour	Silver

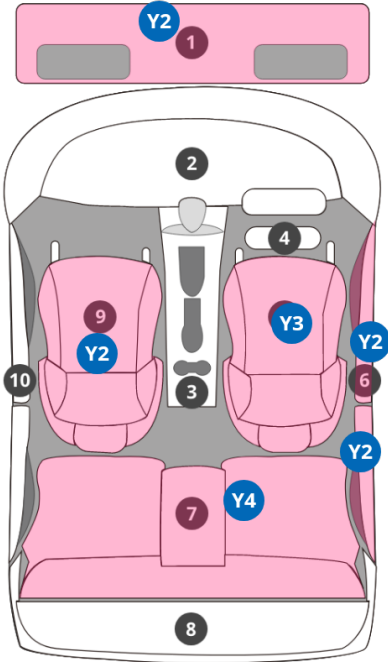
Interior Evaluation : C	Exterior Evaluation : D

<p>a : Cut, Fray d : Loose, Deformed k : Animal Hair s : Smell t : Cigarette Burns x : Defective y : Stain</p>

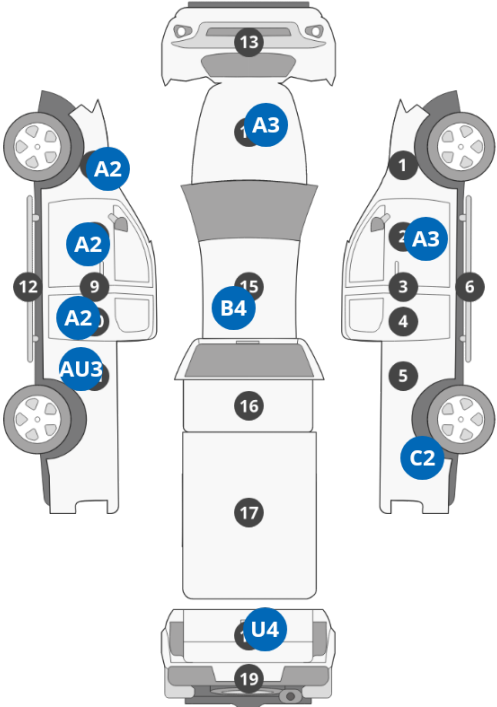
<p>A : Scratch AU : Scratch & Dent B : Modified C : Corrosion G : Stone chip P : Faded S : Rust SC : Rust & Corrosion U : Dent X : Defective Y : Crack, Gap</p>
<p>Remarks (R) Front Seat - Grime - Medium / (R) Front Trim - Grime - Small / (R) Rear Trim - Grime - Small / Rear Seat - Grime - Large / (L) Front Seat - Grime - Small / Ceiling - Grime - Small</p>	<p>Remarks Bonnet - Repair Traces - Yes / (L) Front Fender - Repair Traces - Yes / (L) Rear Door - Repair Traces - Yes / (R) Front Door, Molding - Scratch - Medium / Bonnet, Headlight - Scratch - Medium / (R) Rear Wheel, Cover - Scratch, Corrosion - Small / Rear Gate - Dent - Large / (L) Side Gate - Scratch & Dent - Medium / (L) Rear Door, Molding - Scratch - Small / (L) Front Door, Molding - Scratch - Small / Roof - Modified - Large / (L) Front Fender, Molding - Scratch - Small</p>

<p>Inspector Notes</p>
<p>with spare tire/ large crack on front windshield/ No jack and tools</p>
