General Information

Make	Toyota	Model	Avanza
YOM	2023	Odo Meter Reading	54,680
Registration No.	FAO7132	Chassis No.	MHFAA1BY4P0015576
CC	1.3	Transmission	CVT
Fuel Type	Gas	Type of Body	MPV
Colour	Green

Body / Panel Condition

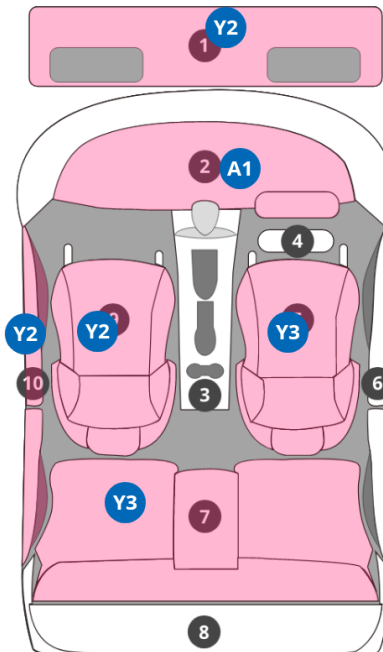
Interior Evaluation : B	Exterior Evaluation : C

<p>a : Cut, Fray d : Loose, Deformed k : Animal Hair s : Smell t : Cigarette Burns x : Defective y : Stain</p>

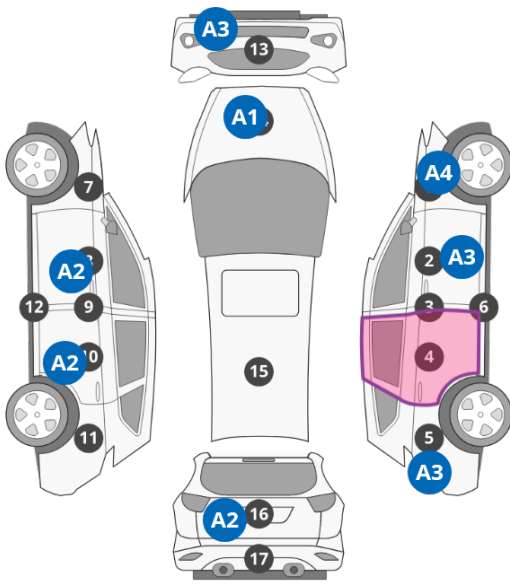
<p>A : Scratch AU : Scratch & Dent B : Modified C : Corrosion G : Stone chip P : Faded S : Rust SC : Rust & Corrosion U : Dent X : Defective Y : Crack, Gap</p>
<p>Remarks (R) Front Seat - Grime - Medium / Rear Seat - Grime - Medium / Ceiling - Grime - Small / (L) Front Seat - Grime - Small / (L) Front Trim - Grime - Small / Dashboard - Worn, Scratch, Cut, Crack - Minimal</p>	<p>Remarks Bonnet, Headlight - Scratch - Minimal / Front Bumper, Grille, Lamps - Scratch - Medium / (R) Front Fender, Molding - Scratch - Large / (R) Front Door, Molding - Scratch - Medium / (R) Rear Door, Molding - Repair mark - Yes / (R) Rear Fender, Molding - Scratch - Medium / (L) Rear Door, Molding - Scratch - Small / Trunk Hood, Rear Gate - Scratch - Small / (L) Front Door, Molding - Scratch - Small</p>

<p>Inspector Notes</p>
<p>With LTO plate/ No spare tire/with 1 spare key/ right front panel faded color/</p>
