General Information

Make	Toyota	Model	Vios
YOM	2025	Odo Meter Reading	31,275
Registration No.	GBE9804	Chassis No.	PA1B18F39R4268559
CC	1.3	Transmission	CVT
Fuel Type	Gas	Type of Body	Sedan
Colour	Black

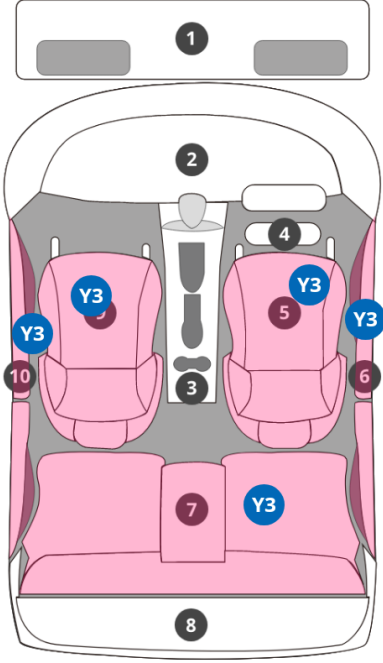
Interior Evaluation : C	Exterior Evaluation : B

<p>a : Cut, Fray d : Loose, Deformed k : Animal Hair s : Smell t : Cigarette Burns x : Defective y : Stain</p>

<p>A : Scratch AU : Scratch & Dent B : Modified C : Corrosion G : Stone chip P : Faded S : Rust SC : Rust & Corrosion U : Dent X : Defective Y : Crack, Gap</p>
<p>Remarks (R) Front Trim - Grime - Medium / (R) Front Seat - Grime - Medium / Rear Seat - Grime - Medium / (L) Front Seat - Grime - Medium / (L) Front Trim - Grime - Medium</p>	<p>Remarks (L) Rear Fender - Repair Traces - Yes / Bonnet, Headlight - Dent - Small / Trunk Hood, Rear Gate - Scratch - Minimal / (L) Front Fender, Molding - Scratch - Minimal / (R) Rear Fender, Molding - Scratch - Minimal / (L) Front Door, Molding - Scratch - Small / (L) Rear Door, Molding - Scratch - Medium</p>
Frame Evaluation : A	Functional Evaluation : A
<p>Remarks Defects not found</p>	<p>Remarks Spare Key - Issue - Unexist</p>
