## General Information

<b>Make</b>	Toyota	<b>Model</b>	Wigo
<b>YOM</b>	2025	<b>Odo Meter Reading</b>	12,031
<b>Registration No.</b>	GBJ3583	<b>Chassis No.</b>	MHKAA1BC8RJ032528
<b>CC</b>	1.0	<b>Transmission</b>	CVT
<b>Fuel Type</b>	Gas	<b>Type of Body</b>	Hatchback
<b>Colour</b>	Orange

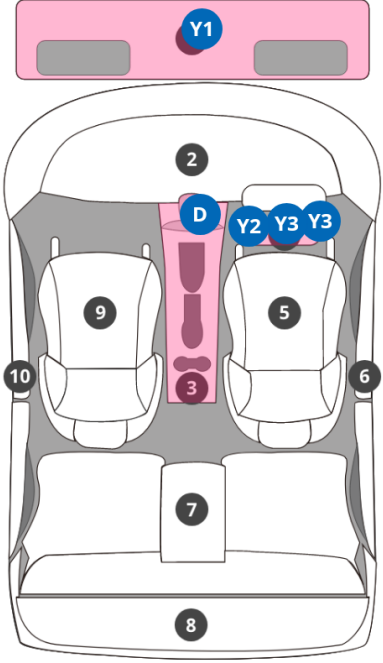
<b>Interior Evaluation :</b> <span style="float: right;"><b>B</b></span>	<b>Exterior Evaluation :</b> <span style="float: right;"><b>C</b></span>

<p><b>a</b> : Cut, Fray <b>d</b> : Loose, Deformed <b>k</b> : Animal Hair <b>s</b> : Smell <b>t</b> : Cigarette Burns <b>x</b> : Defective <b>y</b> : Stain</p>

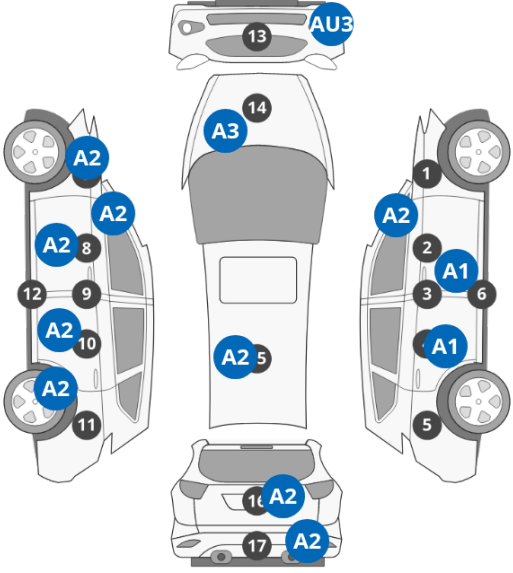
<p><b>A</b> : Scratch <b>AU</b> : Scratch &amp; Dent <b>B</b> : Modified <b>C</b> : Corrosion <b>G</b> : Stone chip <b>P</b> : Faded <b>S</b> : Rust <b>SC</b> : Rust &amp; Corrosion <b>U</b> : Dent <b>X</b> : Defective <b>Y</b> : Crack, Gap</p>
<p><b>Remarks</b> (R) Front Floor Mat - Grime - Medium / Mat Other - Grime - Medium / (L) Front Floor Mat - Grime - Small / Ceiling - Grime - Minimal / Console, Switchs, Vents - Repair Mark - Yes</p>	<p><b>Remarks</b> Rear Bumper, Lamps, Panels - Scratch - Small / Trunk Hood, Rear Gate - Scratch - Small / (L) Rear Fender, Molding - Scratch - Small / (R) Rear Door, Molding - Scratch - Minimal / (R) Front Door, Molding - Scratch - Minimal / (R) Mirror - Scratch - Small / Front Bumper, Grille, Lamps - Scratch &amp; Dent - Medium / (L) Front Fender, Molding - Scratch - Small / (L) Mirror - Scratch - Small / (L) Front Door, Molding - Scratch - Small / (L) Rear Door, Molding - Scratch - Small / Bonnet, Headlight - Scratch - Medium / Roof - Scratch - Small</p>
