General Information

Make	Toyota	Model	Avanza
YOM	2024	Odo Meter Reading	27,595
Registration No.	CCG3782	Chassis No.	MHFAA1BY2P007813
CC	1.3	Transmission	CVT
Fuel Type	Gas	Type of Body	Wagon
Colour	Black

Body / Panel Condition

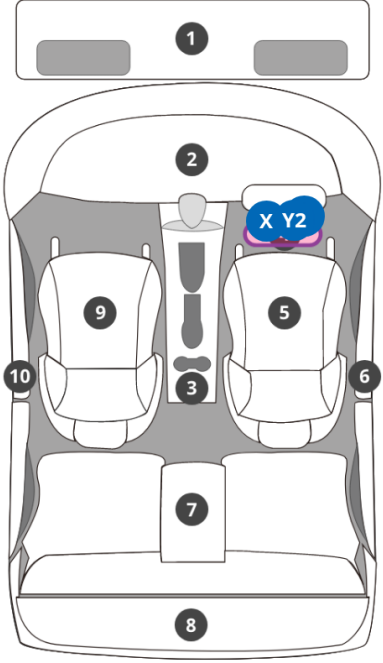
Interior Evaluation : B	Exterior Evaluation : C

<p>a : Cut, Fray d : Loose, Deformed k : Animal Hair s : Smell t : Cigarette Burns x : Defective y : Stain</p>

<p>A : Scratch AU : Scratch & Dent B : Modified C : Corrosion G : Stone chip P : Faded S : Rust SC : Rust & Corrosion U : Dent X : Defective Y : Crack, Gap</p>
<p>Remarks (R) Front Floor Mat - Missing - Yes / Mat Other - Missing - Yes / (L) Front Floor Mat - Grime - Small</p>	<p>Remarks Trunk Hood, Rear Gate - Repair Traces - Yes / (R) Front Fender, Molding - Scratch - Minimal / (R) Step, In-panel, Side Spoiler - Scratch - Medium / (R) Front Door, Molding - Scratch - Minimal / (R) Rear Door, Molding - Scratch - Small / (R) Rear Fender, Molding - Scratch & Dent - Minimal / Rear Bumper, Lamps, Panels - Scratch & Dent - Small / Trunk Hood, Rear Gate - Scratch - Minimal / (L) Rear Fender, Molding - Dent - Minimal / (L) Step, In-panel, Side Spoiler - Scratch & Dent - Medium / (L) Rear Door, Molding - Scratch - Minimal / (L) Mirror - Scratch - Minimal / (L) Front Door, Molding - Scratch - Small / Front Bumper, Grille, Lamps - Crack, Gap - Medium / Bonnet, Headlight - Scratch - Minimal / Roof - Rust, Corrosion - Small</p>

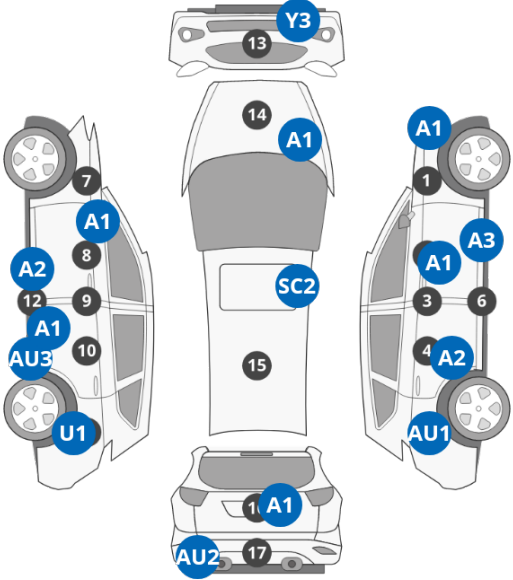
<p>Inspector Notes</p>
<p>With Lto plate, with spare tire, 2keys, no jack and tools, no warranty booklet, scratches on headlights and taillights, cover under hood missing</p>
