General Information

Make	Toyota	Model	Avanza
YOM	2025	Odo Meter Reading	35,225
Registration No.	CCJ1704	Chassis No.	MHFAA1BY3R0032713
CC	1.3	Transmission	CVT
Fuel Type	Gas	Type of Body	Wagon
Colour	Red

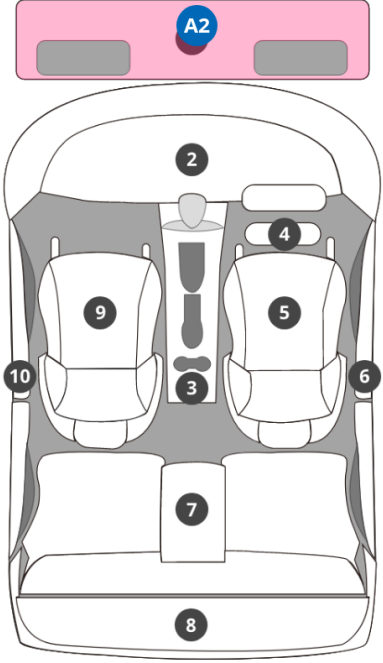
<p>a : Cut, Fray d : Loose, Deformed k : Animal Hair s : Smell t : Cigarette Burns x : Defective y : Stain</p>

<p>A : Scratch AU : Scratch & Dent B : Modified C : Corrosion G : Stone chip P : Faded S : Rust SC : Rust & Corrosion U : Dent X : Defective Y : Crack, Gap</p>
Remarks Ceiling - Cut, Crack - Small	Remarks (R) Front Fender, Molding - Scratch - Minimal / (R) Mirror - Scratch - Minimal / (R) Front Door, Molding - Scratch - Minimal / (R) Step, In-panel, Side Spoiler - Scratch - Minimal / (R) Rear Door, Molding - Scratch - Minimal / (R) Rear Fender, Molding - Scratch - Minimal / Trunk Hood, Rear Gate - Scratch - Minimal / Rear Bumper, Lamps, Panels - Scratch - Minimal / Roof - Scratch - Minimal / (L) Rear Door, Molding - Scratch & Dent - Minimal / (L) Step, In-panel, Side Spoiler - Scratch & Dent - Large / (L) Front Door, Molding - Scratch & Dent - Large / (L) Mirror - Scratch - Minimal / (L) Front Fender, Molding - Scratch - Minimal / Bonnet, Headlight - Scratch - Minimal / Front Bumper, Grille, Lamps - Scratch - Small
