General Information

Make	Toyota	Model	Avanza
YOM	2022	Odo Meter Reading	19,666
Registration No.	CBD8798	Chassis No.	MHFAABY1N0002443
CC	1.3	Transmission	M/T
Fuel Type	Gas	Type of Body	Wagon
Colour	Silver

Body / Panel Condition

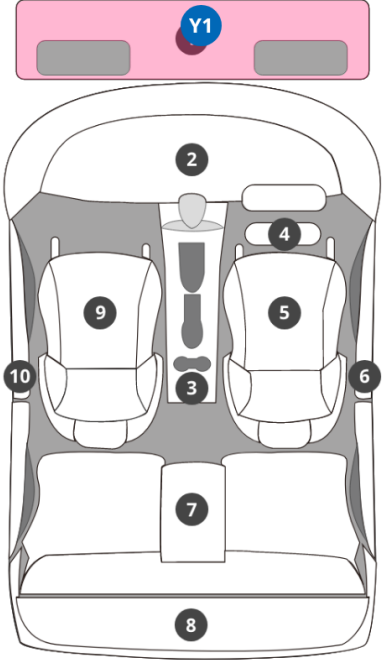
Interior Evaluation : A	Exterior Evaluation : D

<p>a : Cut, Fray d : Loose, Deformed k : Animal Hair s : Smell t : Cigarette Burns x : Defective y : Stain</p>

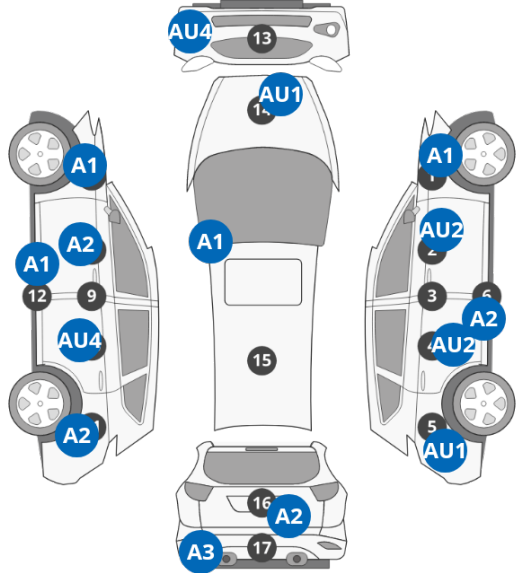
<p>A : Scratch AU : Scratch & Dent B : Modified C : Corrosion G : Stone chip P : Faded S : Rust SC : Rust & Corrosion U : Dent X : Defective Y : Crack, Gap</p>
<p>Remarks Ceiling - Grime - Minimal</p>	<p>Remarks (R) Front Fender, Molding - Scratch - Minimal / (R) Front Door, Molding - Scratch & Dent - Small / (R) Step, In-panel, Side Spoiler - Scratch - Small / (R) Rear Door, Molding - Scratch & Dent - Small / (R) Rear Fender, Molding - Scratch & Dent - Minimal / Rear Bumper, Lamps, Panels - Scratch - Medium / (L) Rear Fender, Molding - Scratch - Small / (L) Rear Door, Molding - Scratch & Dent - Large / (L) Step, In-panel, Side Spoiler - Scratch - Minimal / (L) Front Door, Molding - Scratch - Small / (L) Front Fender, Molding - Scratch - Minimal / Bonnet, Headlight - Scratch & Dent - Minimal / Front Bumper, Grille, Lamps - Scratch & Dent - Large / Roof - Scratch - Minimal / Trunk Hood, Rear Gate - Scratch - Small</p>

<p>Inspector Notes</p>
<p>With Lto plate, with warranty booklet, with spare tire, 2keys, no jack and tools, scratches on headlights and taillights</p>
