General Information

Make	Toyota	Model	Hilux
YOM	2024	Odo Meter Reading	13,592
Registration No.	DBM3667	Chassis No.	MR0AB8DD5R5150889
CC	2.4	Transmission	A/T
Fuel Type	Diesel	Type of Body	Pickup
Colour	White

Body / Panel Condition

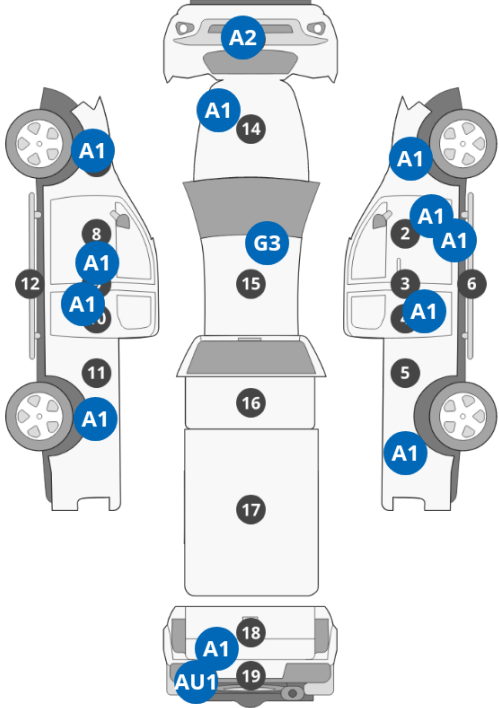
<p>A : Scratch AU : Scratch & Dent B : Modified C : Corrosion G : Stone chip P : Faded S : Rust SC : Rust & Corrosion U : Dent X : Defective Y : Crack, Gap</p>
Remarks Defects not found	Remarks Front Windshield - Scratch, Stone chip - Medium / (R) Front Fender, Molding - Scratch - Minimal / (R) Front Door, Molding - Scratch - Minimal / (R) Step, In-panel, Side Spoiler - Scratch - Minimal / (R) Rear Door, Molding - Scratch - Minimal / (R) Side Gate - Scratch - Minimal / Rear Bumper, Lamps, Panels - Scratch & Dent - Minimal / Rear Gate - Scratch - Minimal / (L) Side Gate - Scratch - Minimal / (L) Rear Door, Molding - Scratch - Minimal / (L) Front Door, Molding - Scratch - Minimal / (L) Front Fender, Molding - Scratch - Minimal / Bonnet, Headlight - Scratch - Minimal / Front Bumper, Grille, Lamps - Scratch - Small

Inspector Notes
With Lto plate, with warranty booklet, with spare tire and jack, 4keys, no tools, scratches on headlights,
