General Information

Make	Nissan	Model	Navara
YOM	2022	Odo Meter Reading	41,763
Registration No.	NGY4539	Chassis No.	MNTCCAD23Z0006596
CC	2.5	Transmission	A/T
Fuel Type	Diesel	Type of Body	Pickup
Colour	White

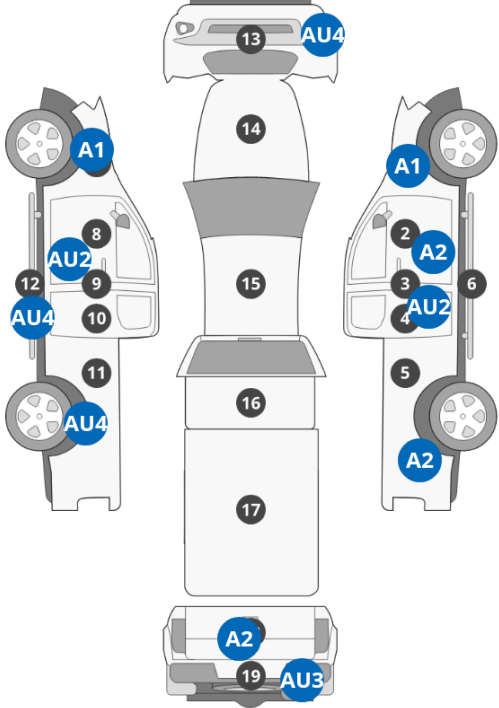
<p>A : Scratch AU : Scratch & Dent B : Modified C : Corrosion G : Stone chip P : Faded S : Rust SC : Rust & Corrosion U : Dent X : Defective Y : Crack, Gap</p>
Remarks Defects not found	Remarks (L) Front Door, Molding - Scratch & Dent - Small / Rear Bumper, Lamps, Panels - Scratch & Dent - Medium / (R) Rear Door, Molding - Scratch & Dent - Small / Front Bumper, Grille, Lamps - Scratch & Dent - Large / (L) Side Gate - Scratch & Dent - Large / (L) Step, In-panel, Side Spoiler - Scratch & Dent - Large / (R) Front Fender, Molding - Scratch - Minimal / (R) Front Door, Molding - Scratch - Small / (L) Front Fender, Molding - Scratch - Minimal / (R) Side Gate - Scratch - Small / Rear Gate - Scratch - Small
Frame Evaluation : A	Functional Evaluation : A
