General Information

Make	Suzuki	Model	XL7
YOM	2025	Odo Meter Reading	6,531
Registration No.	NKP6012	Chassis No.	MHYNC32S1TJ100180
CC	1.5	Transmission	A/T
Fuel Type	Gas	Type of Body	Wagon
Colour	White

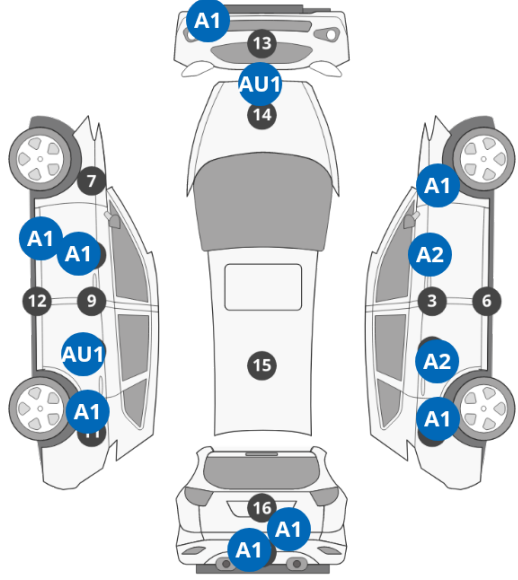
<p>A : Scratch AU : Scratch & Dent B : Modified C : Corrosion G : Stone chip P : Faded S : Rust SC : Rust & Corrosion U : Dent X : Defective Y : Crack, Gap</p>
Remarks Defects not found	Remarks (R) Front Fender, Molding - Scratch - Minimal / (R) Front Door, Molding - Scratch - Small / (R) Rear Door, Molding - Scratch - Small / (R) Rear Fender, Molding - Scratch - Minimal / Rear Bumper, Lamps, Panels - Scratch - Minimal / Trunk Hood, Rear Gate - Scratch - Minimal / (L) Rear Fender, Molding - Scratch - Minimal / (L) Step, In-panel, Side Spoiler - Scratch - Minimal / (L) Rear Door, Molding - Scratch & Dent - Minimal / (L) Front Door, Molding - Scratch - Minimal / Bonnet, Headlight - Scratch & Dent - Minimal / Front Bumper, Grille, Lamps - Scratch - Minimal

Inspector Notes
No original Lto plate, with spare tire and jack, 1key, no warranty booklet and tools, scratches on headlights and taillights
