General Information

Make	Toyota	Model	Vios
YOM	2025	Odo Meter Reading	15,968
Registration No.	DBU7240	Chassis No.	PA1B18F32R4277992
CC	1.3	Transmission	CVT
Fuel Type	Gas	Type of Body	Sedan
Colour	Red

Body / Panel Condition

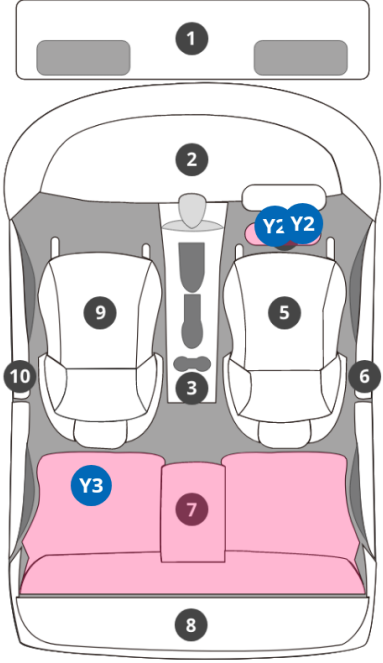
Interior Evaluation : B	Exterior Evaluation : E

<p>a : Cut, Fray d : Loose, Deformed k : Animal Hair s : Smell t : Cigarette Burns x : Defective y : Stain</p>

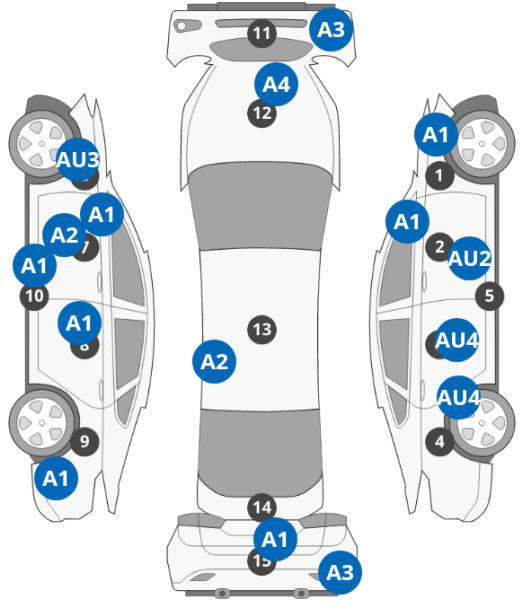
<p>A : Scratch AU : Scratch & Dent B : Modified C : Corrosion G : Stone chip P : Faded S : Rust SC : Rust & Corrosion U : Dent X : Defective Y : Crack, Gap</p>
<p>Remarks (L) Front Floor Mat - Grime - Small / (R) Front Floor Mat - Grime - Small / Rear Seat - Grime - Medium</p>	<p>Remarks Bonnet - Repair Traces - Yes / (L) Front Door - Repair Traces - Yes / (L) Rear Door - Repair Traces - Yes / (R) Front Fender, Molding - Scratch - Minimal / (R) Mirror - Scratch - Minimal / (R) Front Door, Molding - Scratch & Dent - Small / (R) Rear Door, Molding - Scratch & Dent - Large / (R) Rear Fender, Molding - Scratch & Dent - Large / Rear Bumper, Lamps, Panels - Scratch - Medium / Trunk Hood, Rear Gate - Scratch - Minimal / Roof - Scratch - Small / (L) Rear Fender, Molding - Scratch - Minimal / (L) Rear Door, Molding - Scratch - Minimal / (L) Mirror - Scratch - Minimal / (L) Front Door, Molding - Scratch - Small / (L) Step, In-panel, Side Spoiler - Scratch - Minimal / (L) Front Fender, Molding - Scratch & Dent - Medium / Bonnet, Headlight - Scratch - Large / Front Bumper, Grille, Lamps - Scratch - Medium</p>
