General Information

Make	Toyota	Model	Vios
YOM	2021	Odo Meter Reading	30,456
Registration No.	NEO9618	Chassis No.	PA1B18F38M4145019
CC	1.3	Transmission	CVT
Fuel Type	Gas	Type of Body	Sedan
Colour	Blue

Body / Panel Condition

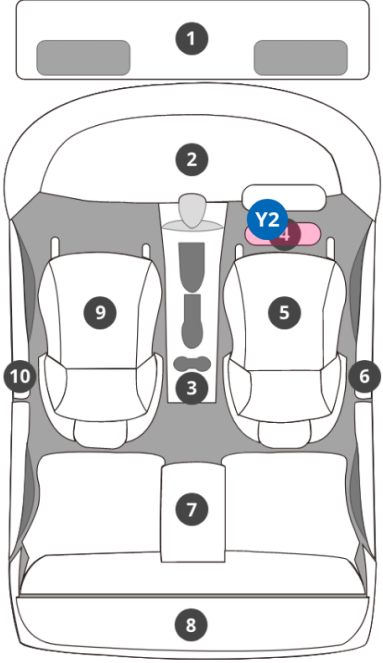
Interior Evaluation : A	Exterior Evaluation : B

<p>a : Cut, Fray d : Loose, Deformed k : Animal Hair s : Smell t : Cigarette Burns x : Defective y : Stain</p>

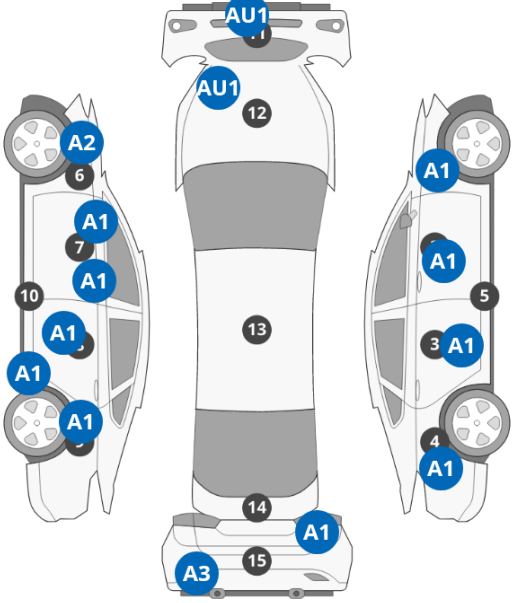
<p>A : Scratch AU : Scratch & Dent B : Modified C : Corrosion G : Stone chip P : Faded S : Rust SC : Rust & Corrosion U : Dent X : Defective Y : Crack, Gap</p>
Remarks (L) Front Floor Mat - Grime - Small	Remarks (R) Front Fender, Molding - Scratch - Minimal / (R) Front Door, Molding - Scratch - Minimal / (R) Rear Door, Molding - Scratch - Minimal / (R) Rear Fender, Molding - Scratch - Minimal / Rear Bumper, Lamps, Panels - Scratch - Medium / Trunk Hood, Rear Gate - Scratch - Minimal / (L) Rear Fender, Molding - Scratch - Minimal / (L) Step, In-panel, Side Spoiler - Scratch - Minimal / (L) Rear Door, Molding - Scratch - Minimal / (L) Mirror - Scratch - Minimal / (L) Front Door, Molding - Scratch - Minimal / (L) Front Fender, Molding - Scratch - Small / Bonnet, Headlight - Scratch & Dent - Minimal / Front Bumper, Grille, Lamps - Scratch & Dent - Minimal
