## General Information

<b>Make</b>	Toyota	<b>Model</b>	Vios
<b>YOM</b>	2025	<b>Odo Meter Reading</b>	39,862
<b>Registration No.</b>	CCG3983	<b>Chassis No.</b>	PA1B18F30R4268885
<b>CC</b>	1.3	<b>Transmission</b>	CVT
<b>Fuel Type</b>	Gas	<b>Type of Body</b>	Sedan
<b>Colour</b>	Black

## Body / Panel Condition

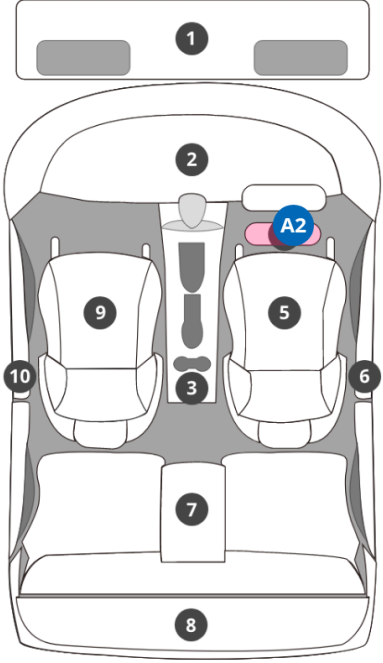
<b>Interior Evaluation :</b> <span style="color: red; font-weight: bold; font-size: 1.2em;">A</span>	<b>Exterior Evaluation :</b> <span style="color: red; font-weight: bold; font-size: 1.2em;">C</span>

<p><b>A</b> : Scratch <b>AU</b> : Scratch &amp; Dent <b>B</b> : Modified <b>C</b> : Corrosion <b>G</b> : Stone chip <b>P</b> : Faded <b>S</b> : Rust <b>SC</b> : Rust &amp; Corrosion <b>U</b> : Dent <b>X</b> : Defective <b>Y</b> : Crack, Gap</p>
<p><b>Remarks</b> (L) Front Floor Mat - Cut, Crack - Small</p>	<p><b>Remarks</b> (R) Mirror - Scratch - Minimal / (R) Front Door, Molding - Scratch - Large / (R) Rear Door, Molding - Scratch - Medium / (R) Step, In-panel, Side Spoiler - Scratch - Medium / Rear Bumper, Lamps, Panels - Scratch - Small / (R) Rear Fender, Molding - Scratch - Minimal / Trunk Hood, Rear Gate - Scratch - Minimal / (L) Rear Fender, Molding - Scratch &amp; Dent - Minimal / (L) Rear Door, Molding - Scratch &amp; Dent - Small / (L) Front Door, Molding - Scratch &amp; Dent - Minimal / Bonnet, Headlight - Repair mark - Yes / Bonnet, Headlight - Scratch - Minimal / (L) Front Fender, Molding - Scratch - Minimal / Front Bumper, Grille, Lamps - Crack, Gap - Medium / Roof - Scratch - Minimal</p>

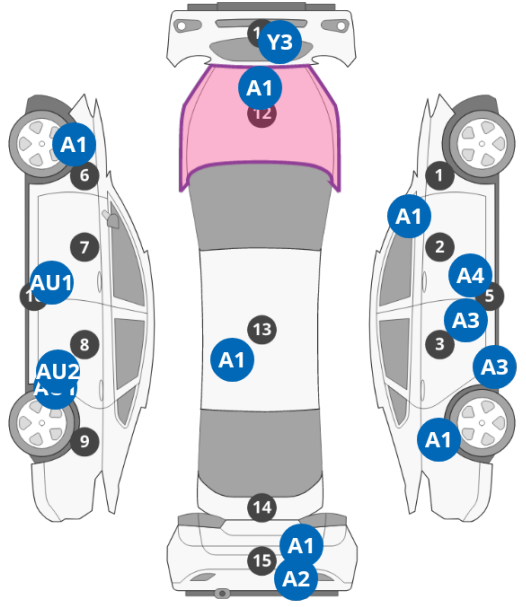
<p><b>Inspector Notes</b></p>
<p>With Lto plate, with jack and tools, 1key, no warranty booklet and spare tire, scratches on headlights, scratches on F windshield, battery weak</p>
