General Information

Make	Toyota	Model	Vios
YOM	2026	Odo Meter Reading	8,272
Registration No.	CCQ4514	Chassis No.	PA1B1F30S42897082
CC	1.3	Transmission	CVT
Fuel Type	Gas	Type of Body	Sedan
Colour	Blackish Red Mica

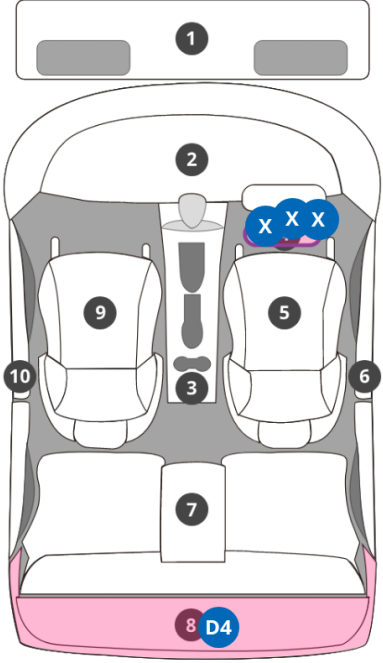
Interior Evaluation : C	Exterior Evaluation : D

<p>a : Cut, Fray d : Loose, Deformed k : Animal Hair s : Smell t : Cigarette Burns x : Defective y : Stain</p>

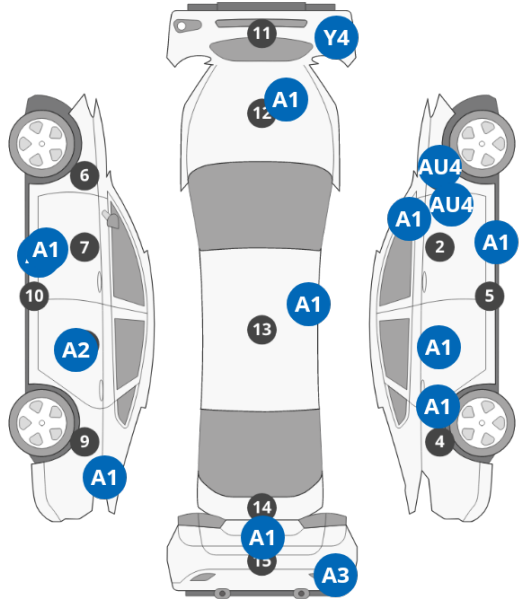
<p>A : Scratch AU : Scratch & Dent B : Modified C : Corrosion G : Stone chip P : Faded S : Rust SC : Rust & Corrosion U : Dent X : Defective Y : Crack, Gap</p>
Remarks (R) Front Floor Mat - Missing - Yes / (L) Front Floor Mat - Missing - Yes / Mat Other - Missing - Yes / Trunk Room - Loose, Deformed - Large	Remarks (R) Front Fender, Molding - Scratch & Dent - Large / (R) Front Door, Molding - Scratch & Dent - Large / (R) Mirror - Scratch - Minimal / (R) Step, In-panel, Side Spoiler - Scratch - Minimal / (R) Rear Door, Molding - Scratch - Minimal / (R) Rear Fender, Molding - Scratch - Minimal / Rear Bumper, Lamps, Panels - Scratch - Medium / Trunk Hood, Rear Gate - Scratch - Minimal / (L) Rear Fender, Molding - Scratch - Minimal / (L) Rear Door, Molding - Scratch - Small / (L) Step, In-panel, Side Spoiler - Scratch - Minimal / (L) Front Door, Molding - Scratch - Minimal / Front Bumper, Grille, Lamps - Crack, Gap - Large / Bonnet, Headlight - Scratch - Minimal / Roof - Scratch - Minimal
