General Information

Make	Toyota	Model	Vios
YOM	2025	Odo Meter Reading	15,406
Registration No.	BAG7327	Chassis No.	PA1B18F39R4279822
CC	1.3	Transmission	CVT
Fuel Type	Gas	Type of Body	Sedan
Colour	Blue

Body / Panel Condition

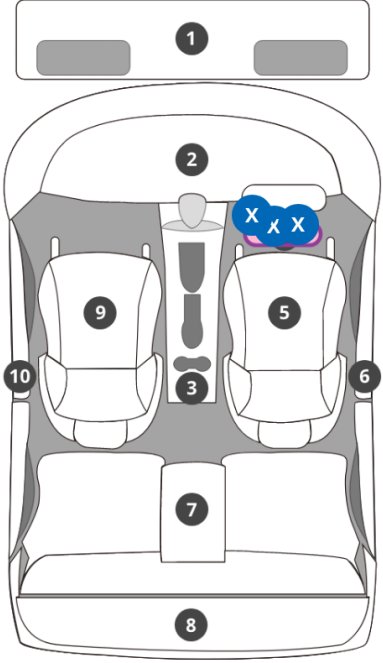
Interior Evaluation : B	Exterior Evaluation : A

<p>a : Cut, Fray d : Loose, Deformed k : Animal Hair s : Smell t : Cigarette Burns x : Defective y : Stain</p>

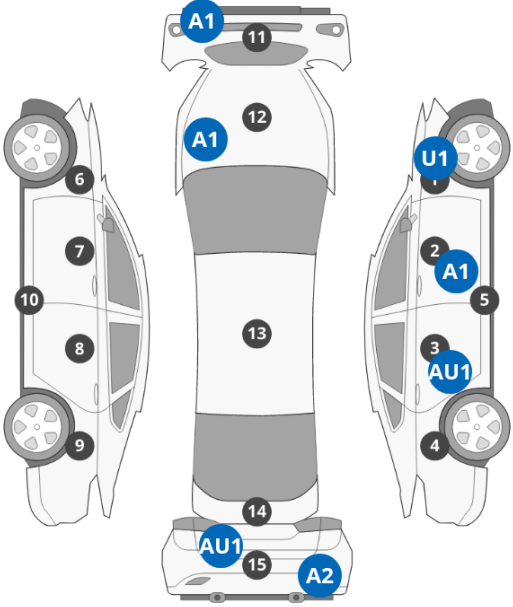
<p>A : Scratch AU : Scratch & Dent B : Modified C : Corrosion G : Stone chip P : Faded S : Rust SC : Rust & Corrosion U : Dent X : Defective Y : Crack, Gap</p>
<p>Remarks (R) Front Floor Mat - Missing - Yes / (L) Front Floor Mat - Missing - Yes / Mat Other - Missing - Yes</p>	<p>Remarks (R) Front Fender, Molding - Dent - Minimal / (R) Front Door, Molding - Scratch - Minimal / (R) Rear Door, Molding - Scratch & Dent - Minimal / Rear Bumper, Lamps, Panels - Scratch - Small / Trunk Hood, Rear Gate - Scratch & Dent - Minimal / Bonnet, Headlight - Scratch - Minimal / Front Bumper, Grille, Lamps - Scratch - Minimal</p>
Frame Evaluation : A	Functional Evaluation : A
<p>Remarks Defects not found</p>	<p>Remarks Defects not found</p>

<p>Inspector Notes</p>
<p>With Lto plate, with warranty booklet, with spare tire, with jack and tools, 3keys, scratches on headlights</p>
