General Information

Make	Toyota	Model	Vios
YOM	2025	Odo Meter Reading	17,356
Registration No.	CAZ9634	Chassis No.	PA1B18F35R4241018
CC	1.3	Transmission	CVT
Fuel Type	Gas	Type of Body	Sedan
Colour	Blue

Body / Panel Condition

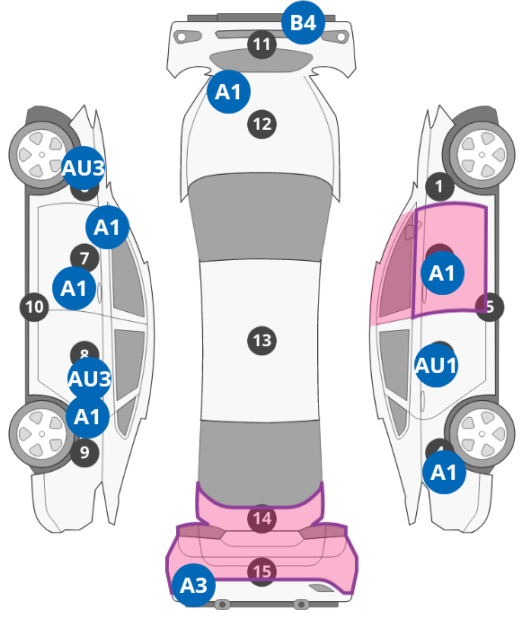
<p>A : Scratch AU : Scratch & Dent B : Modified C : Corrosion G : Stone chip P : Faded S : Rust SC : Rust & Corrosion U : Dent X : Defective Y : Crack, Gap</p>
Remarks Defects not found	Remarks (R) Front Door, Molding - Repair mark - Yes / (R) Front Door, Molding - Scratch - Minimal / (R) Rear Door, Molding - Scratch & Dent - Minimal / (R) Rear Fender, Molding - Scratch - Minimal / Trunk Hood, Rear Gate - Repair mark - Yes / Rear Bumper, Lamps, Panels - Scratch - Medium / (L) Rear Fender, Molding - Scratch - Minimal / (L) Rear Door, Molding - Scratch & Dent - Medium / (L) Mirror - Scratch - Minimal / (L) Front Door, Molding - Scratch - Minimal / (L) Front Fender, Molding - Scratch & Dent - Medium / Bonnet, Headlight - Scratch - Minimal / Front Bumper, Grille, Lamps - Modified - Large

Inspector Notes
With Lto plate, with spare tire and jack, 1key, no warranty booklet and tools, scratches on headlights and taillights, bumper logo missing
