General Information

Make	Toyota	Model	Vios
YOM	2025	Odo Meter Reading	13,455
Registration No.	NJC2302	Chassis No.	PA1B18F39S4286713
CC	1.3	Transmission	CVT
Fuel Type	Gas	Type of Body	Sedan
Colour	Red

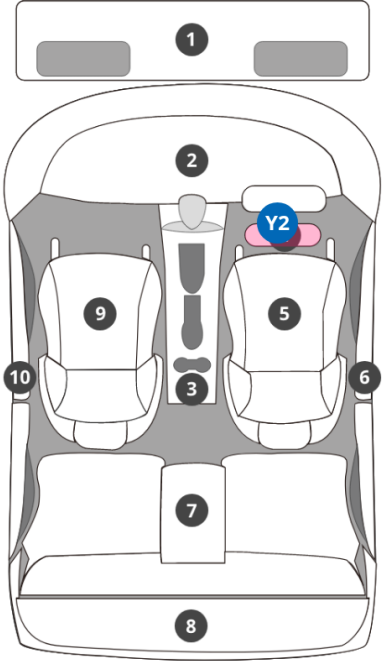
Interior Evaluation : A	Exterior Evaluation : E

<p>a : Cut, Fray d : Loose, Deformed k : Animal Hair s : Smell t : Cigarette Burns x : Defective y : Stain</p>

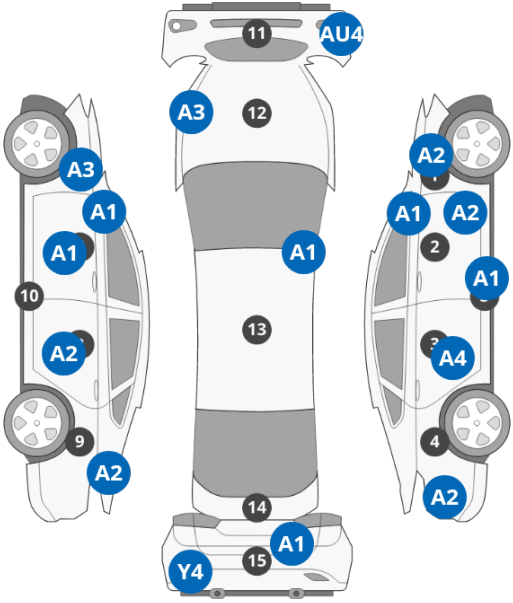
<p>A : Scratch AU : Scratch & Dent B : Modified C : Corrosion G : Stone chip P : Faded S : Rust SC : Rust & Corrosion U : Dent X : Defective Y : Crack, Gap</p>
<p>Remarks (L) Front Floor Mat - Grime - Small</p>	<p>Remarks (R) Front Fender, Molding - Scratch - Small / (R) Mirror - Scratch - Minimal / (R) Front Door, Molding - Scratch - Small / (R) Step, In-panel, Side Spoiler - Scratch - Minimal / (R) Rear Door, Molding - Scratch - Large / (R) Rear Fender, Molding - Scratch - Small / Rear Bumper, Lamps, Panels - Crack, Gap - Large / Trunk Hood, Rear Gate - Scratch - Minimal / (L) Rear Fender, Molding - Scratch - Small / (L) Rear Door, Molding - Scratch - Small / (L) Front Door, Molding - Scratch - Minimal / (L) Mirror - Scratch - Minimal / (L) Front Fender, Molding - Scratch - Medium / Bonnet, Headlight - Scratch - Medium / Roof - Scratch - Minimal / Front Bumper, Grille, Lamps - Scratch & Dent - Large</p>

<p>Inspector Notes</p>
<p>With Lto plate, with warranty booklet, with spare tire, 2keys, no tools and Jack ,scratches on headlights and taillights</p>
