General Information

Make	Toyota	Model	Vios
YOM	2023	Odo Meter Reading	23,244
Registration No.	FAO4701	Chassis No.	PA1B18F32P4203999
CC	1.3	Transmission	CVT
Fuel Type	Gas	Type of Body	Sedan
Colour	Blue

Body / Panel Condition

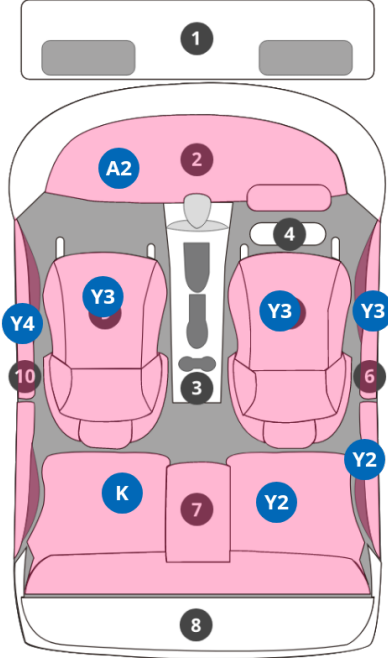
Interior Evaluation : C	Exterior Evaluation : E

<p>a : Cut, Fray d : Loose, Deformed k : Animal Hair s : Smell t : Cigarette Burns x : Defective y : Stain</p>

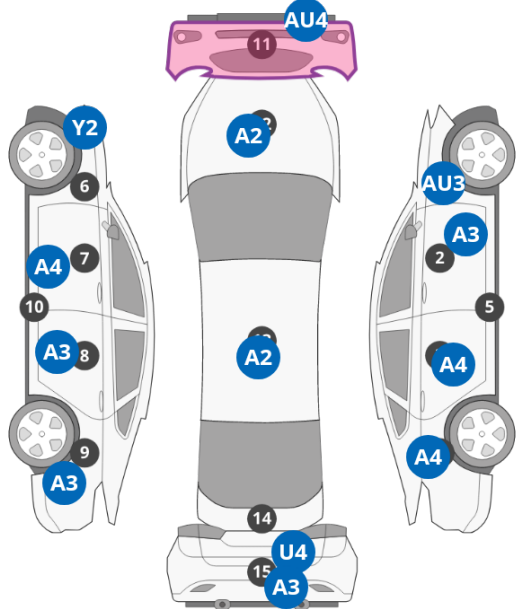
<p>A : Scratch AU : Scratch & Dent B : Modified C : Corrosion G : Stone chip P : Faded S : Rust SC : Rust & Corrosion U : Dent X : Defective Y : Crack, Gap</p>
<p>Remarks (R) Front Trim - Grime - Medium / (R) Front Seat - Grime - Medium / Rear Seat - Grime - Small / (R) Rear Trim - Grime - Small / (L) Front Trim - Grime - Large / (L) Front Seat - Grime - Medium / Dashboard - Worn, Scratch, Cut, Crack - Small / Overall Interior - Animal Hair - Yes</p>	<p>Remarks Front Bumper, Grille, Lamps - Repair mark - Yes / Front Bumper, Grille, Lamps - Scratch & Dent - Large / (R) Front Fender, Molding - Scratch & Dent - Medium / (R) Rear Door, Molding - Scratch - Large / (R) Rear Fender, Molding - Scratch - Large / Trunk Hood, Rear Gate - Dent - Large / Rear Bumper, Lamps, Panels - Scratch - Medium / (L) Rear Fender, Molding - Scratch - Medium / (L) Rear Door, Molding - Scratch - Medium / (L) Front Door, Molding - Scratch - Large / (L) Front Fender, Molding - Crack, Gap - Small / Bonnet, Headlight - Scratch - Small / Roof - Scratch - Small / (R) Front Door, Molding - Scratch - Medium</p>
