General Information

Make	Toyota	Model	Vios
YOM	2022	Odo Meter Reading	58,573
Registration No.	NFK5406	Chassis No.	PA1B18F39N4175163
CC	1.3	Transmission	CVT
Fuel Type	Gas	Type of Body	Sedan
Colour	Red

Body / Panel Condition

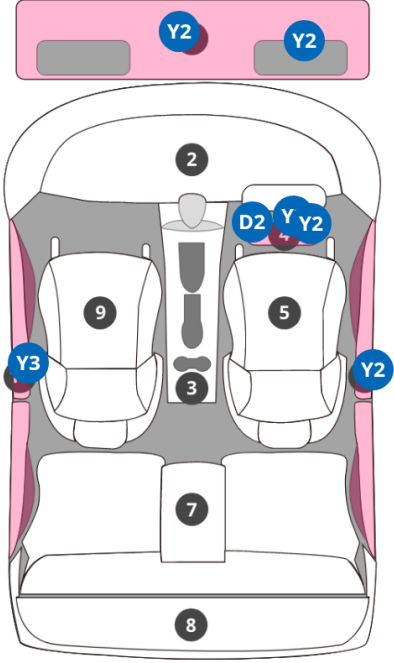
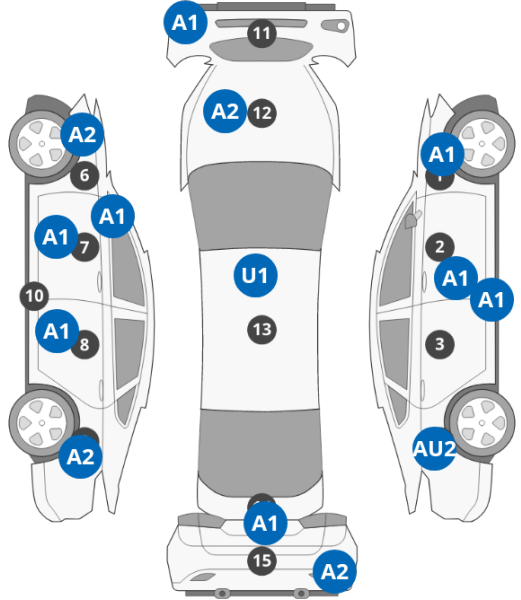
Interior Evaluation :	B	Exterior Evaluation :	B

<p>a : Cut, Fray d : Loose, Deformed k : Animal Hair s : Smell t : Cigarette Burns x : Defective y : Stain</p>		<p>A : Scratch AU : Scratch & Dent B : Modified C : Corrosion G : Stone chip P : Faded S : Rust SC : Rust & Corrosion U : Dent X : Defective Y : Crack, Gap</p>	
<p>Remarks (L) Front Trim - Grime - Medium / (L) Front Floor Mat - Worked - Small / Ceiling - Grime - Small / Sunvisor, Sunglass Holder - Grime - Small / Mat Other - Grime - Medium / (R) Front Floor Mat - Grime - Small / (R) Front Trim - Grime - Small</p>		<p>Remarks (R) Front Fender - Repair Traces - Yes / (L) Mirror - Scratch - Minimal / (L) Front Fender, Molding - Scratch - Small / (L) Rear Door, Molding - Scratch - Minimal / (L) Front Door, Molding - Scratch - Minimal / (L) Rear Fender, Molding - Scratch - Small / Trunk Hood, Rear Gate - Scratch - Minimal / Rear Bumper, Lamps, Panels - Scratch - Small / (R) Rear Fender, Molding - Scratch & Dent - Small / (R) Front Door, Molding - Scratch - Minimal / (R) Front Fender, Molding - Scratch - Minimal / (R) Step, In-panel, Side Spoiler - Scratch - Minimal / Bonnet, Headlight - Scratch - Small / Front Bumper, Grille, Lamps - Scratch - Minimal / Roof - Dent - Minimal</p>
