General Information

Make	Toyota	Model	Raize
YOM	2025	Odo Meter Reading	16,418
Registration No.	DBT4195	Chassis No.	MHKAB1BA1SJ117115
CC	1.2	Transmission	M/T
Fuel Type	Gas	Type of Body	Wagon
Colour	Silver

Body / Panel Condition

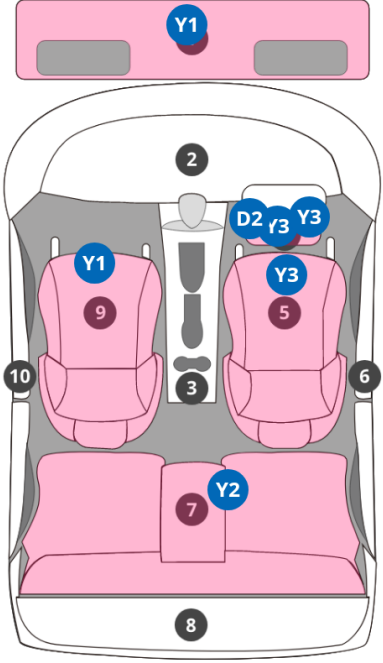
Interior Evaluation : B	Exterior Evaluation : D

<p>a : Cut, Fray d : Loose, Deformed k : Animal Hair s : Smell t : Cigarette Burns x : Defective y : Stain</p>

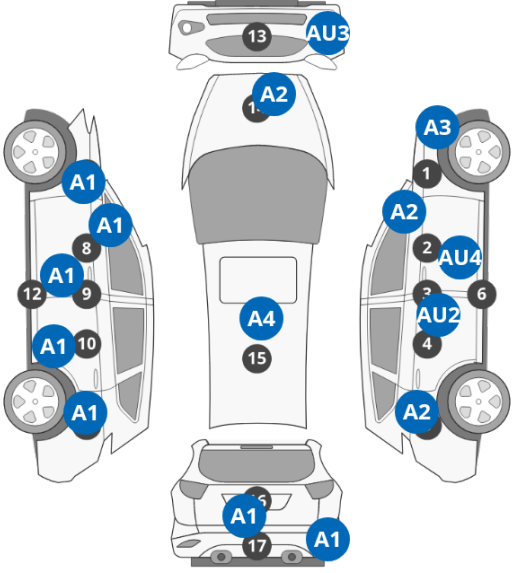
<p>A : Scratch AU : Scratch & Dent B : Modified C : Corrosion G : Stone chip P : Faded S : Rust SC : Rust & Corrosion U : Dent X : Defective Y : Crack, Gap</p>
<p>Remarks Mat Other - Grime - Medium / (R) Front Seat - Grime - Medium / (L) Front Seat - Grime - Minimal / Rear Seat - Grime - Small / (R) Front Floor Mat - Grime - Medium / (L) Front Floor Mat - Worked - Small / Ceiling - Grime - Minimal</p>	<p>Remarks (R) Front Fender, Molding - Scratch - Medium / (R) Mirror - Scratch - Small / (R) Front Door, Molding - Scratch & Dent - Large / (R) Rear Door, Molding - Scratch & Dent - Small / (R) Rear Fender, Molding - Scratch - Small / Rear Bumper, Lamps, Panels - Scratch - Minimal / Trunk Hood, Rear Gate - Scratch - Minimal / (L) Rear Fender, Molding - Scratch - Minimal / (L) Front Door, Molding - Scratch - Minimal / (L) Rear Door, Molding - Scratch - Minimal / (L) Mirror - Scratch - Minimal / (L) Front Fender, Molding - Scratch - Minimal / Front Bumper, Grille, Lamps - Scratch & Dent - Medium / Bonnet, Headlight - Scratch - Small / Roof - Scratch - Large</p>

<p>Inspector Notes</p>
<p>with warranty booklet and jack, no tools, with spare tire, with LTO plate, scratches on tail light,</p>
